IN-SITU METALLOGRAPHY OF CRACKED WELDS IN AN AMMONIA TANK

EXAMPLE REPORT

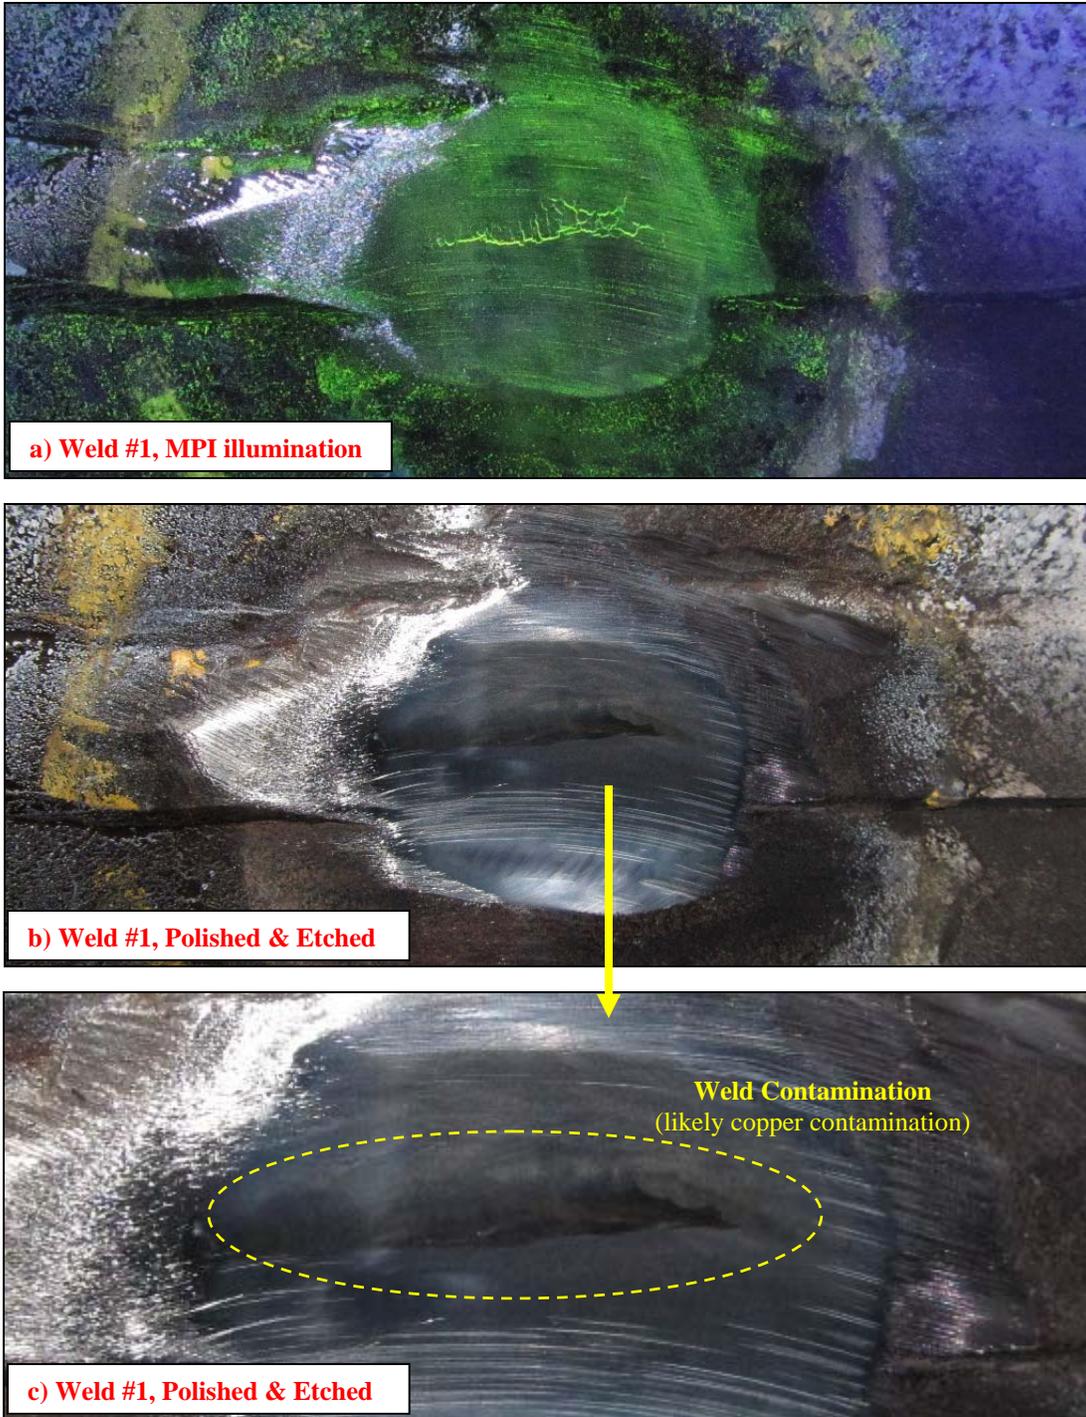
Figure 1: Photographs displaying the features of Weld #1 highlighted by (a) MPI illumination and (b,c) after in-situ preparation including etching. The cracked region of the weld corresponded to a portion of the weld which exhibited contamination. Examination of the structure found the microstructure to be altered, typical of copper contamination.

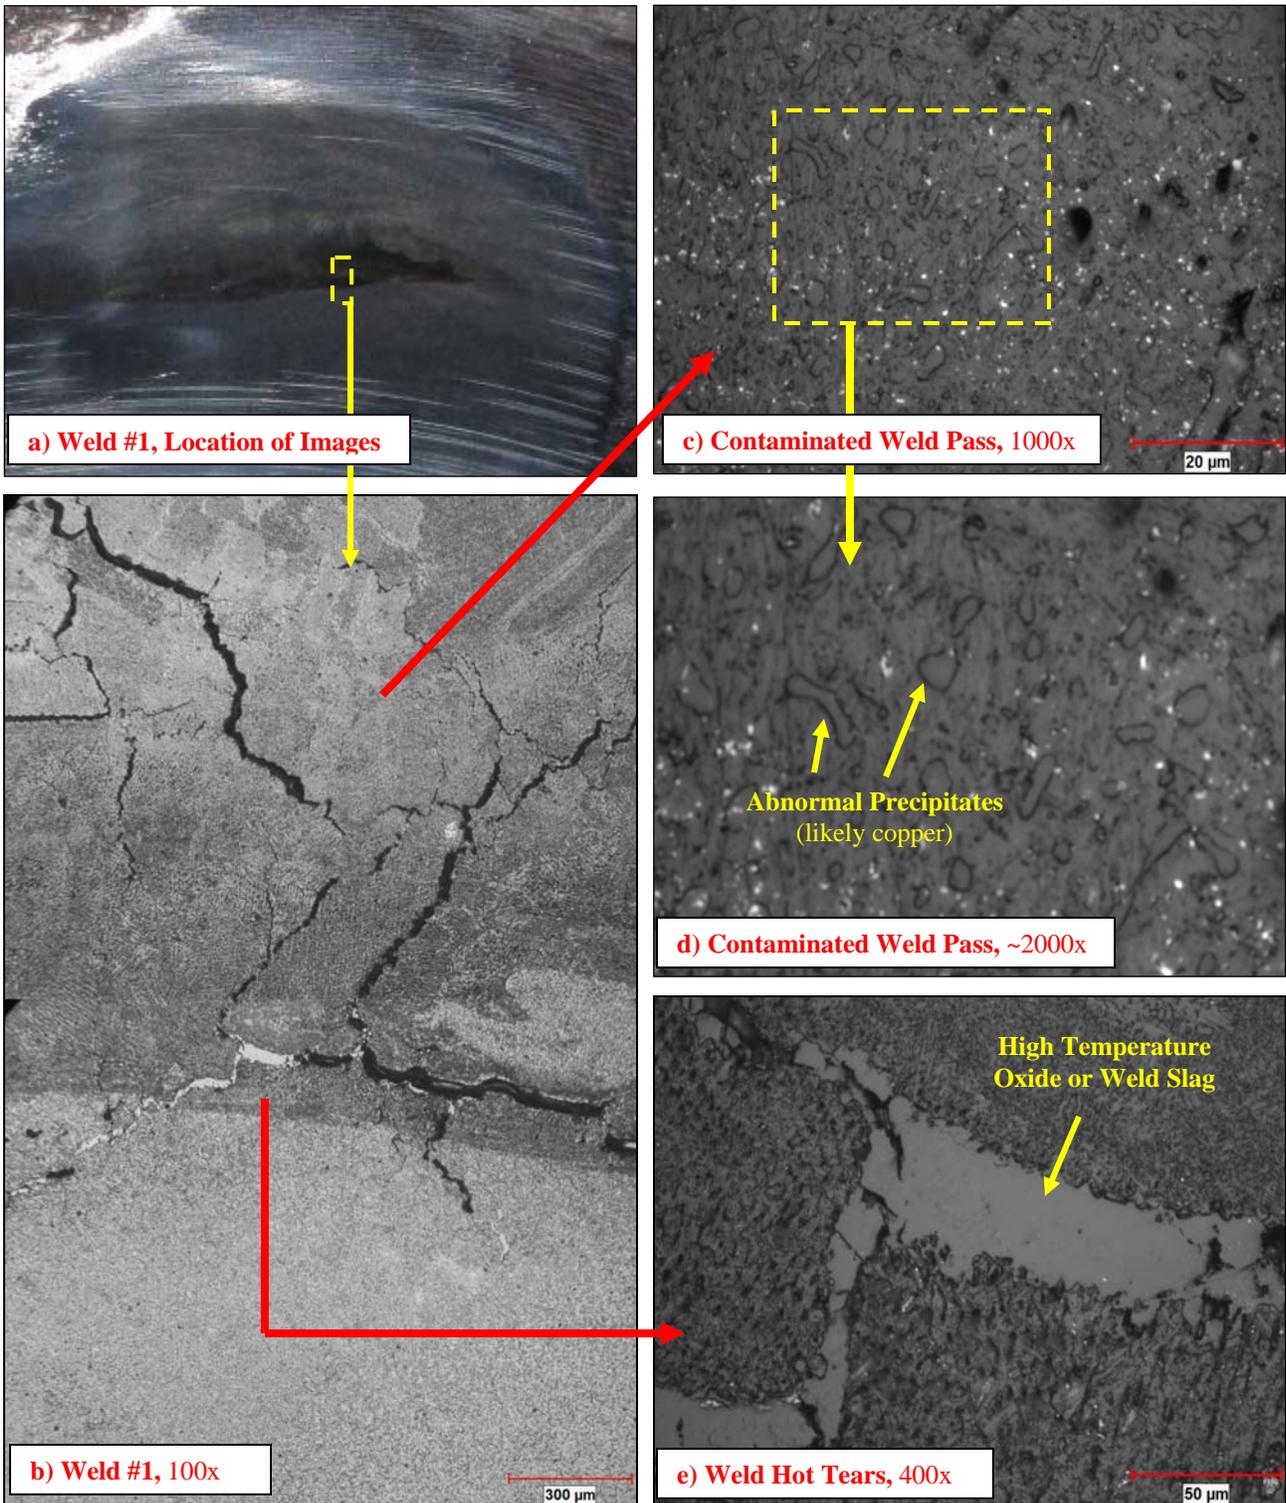
The cracks were hot tears formed during welding manufacture fifty years ago. The hot tears had been caused by copper tip blowout during submerged arc welding (SAW). This had injected copper into the weld and the contamination caused weld hot tears to form. These hot tear cracks had been benign in service.

Figure 2: Micrographs taken from replicas of Weld #1. (b) Numerous hot tear cracks were observed throughout the contaminated portion of the weld. These cracks had formed during welding at initial construction. (c,d) The cracked portion of the weld exhibited an abnormal microstructure comprising of a precipitated phase, likely copper. (e) Oxides or weld slag were present within the weld, formed while hot from welding. Images taken from replications, etched on-site using 3% nital.

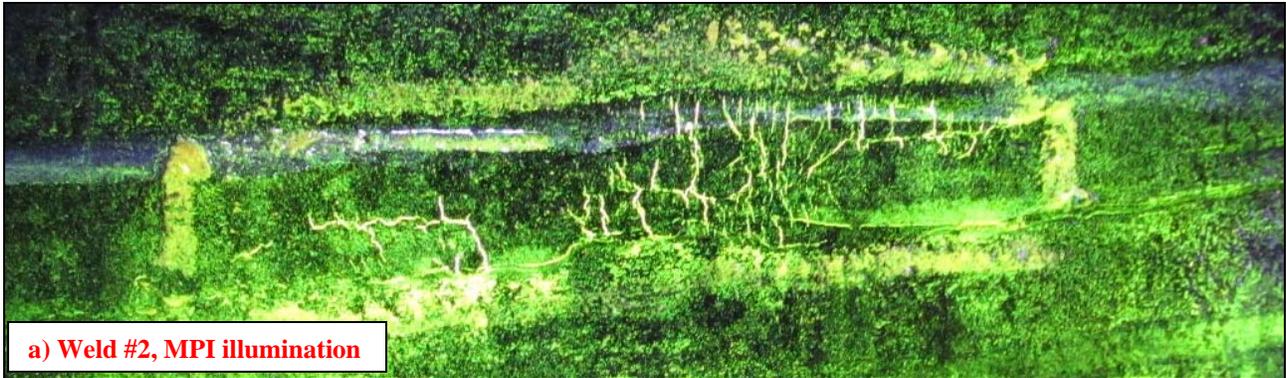
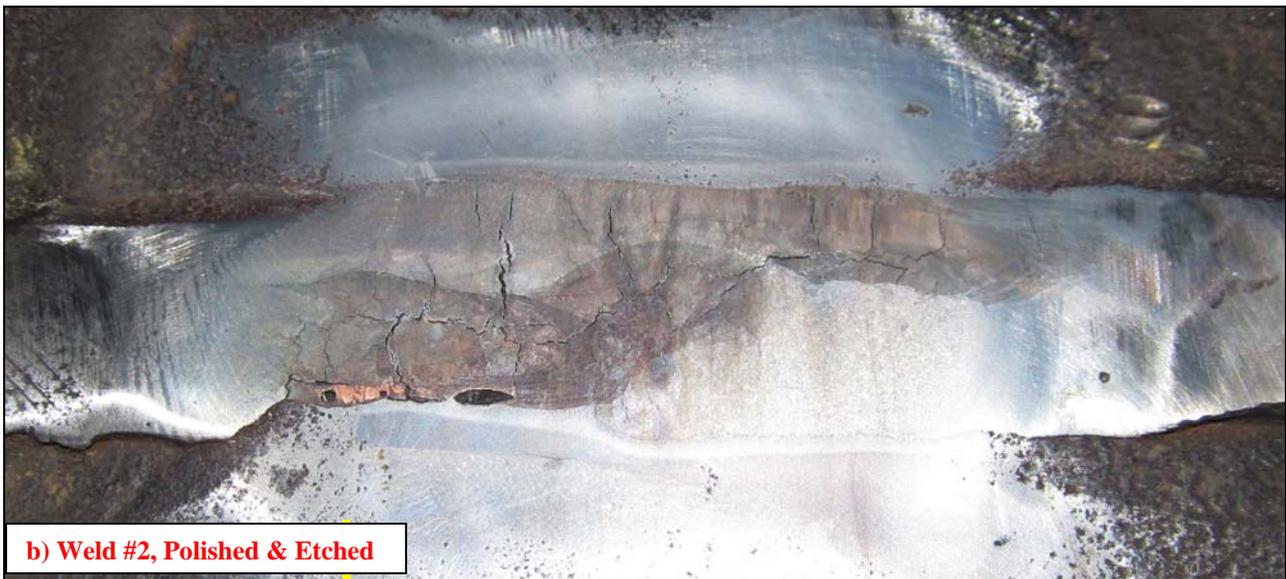
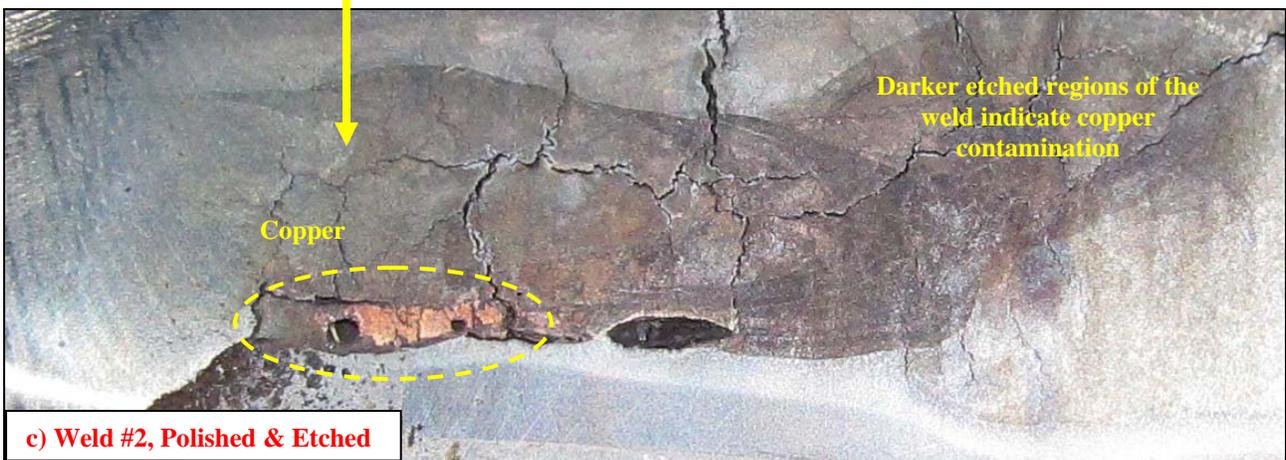
Figure 3: Photographs displaying the features of Weld #2 highlighted by (a) MPI illumination and (b,c) after in-situ preparation, including etching. The weld comprised of numerous cracks throughout. After polishing and etching, copper was visible. Portions of the weld contaminated with copper etched darker than the remainder of the weld. The copper contamination was responsible for the numerous hot tears which formed during initial welding.

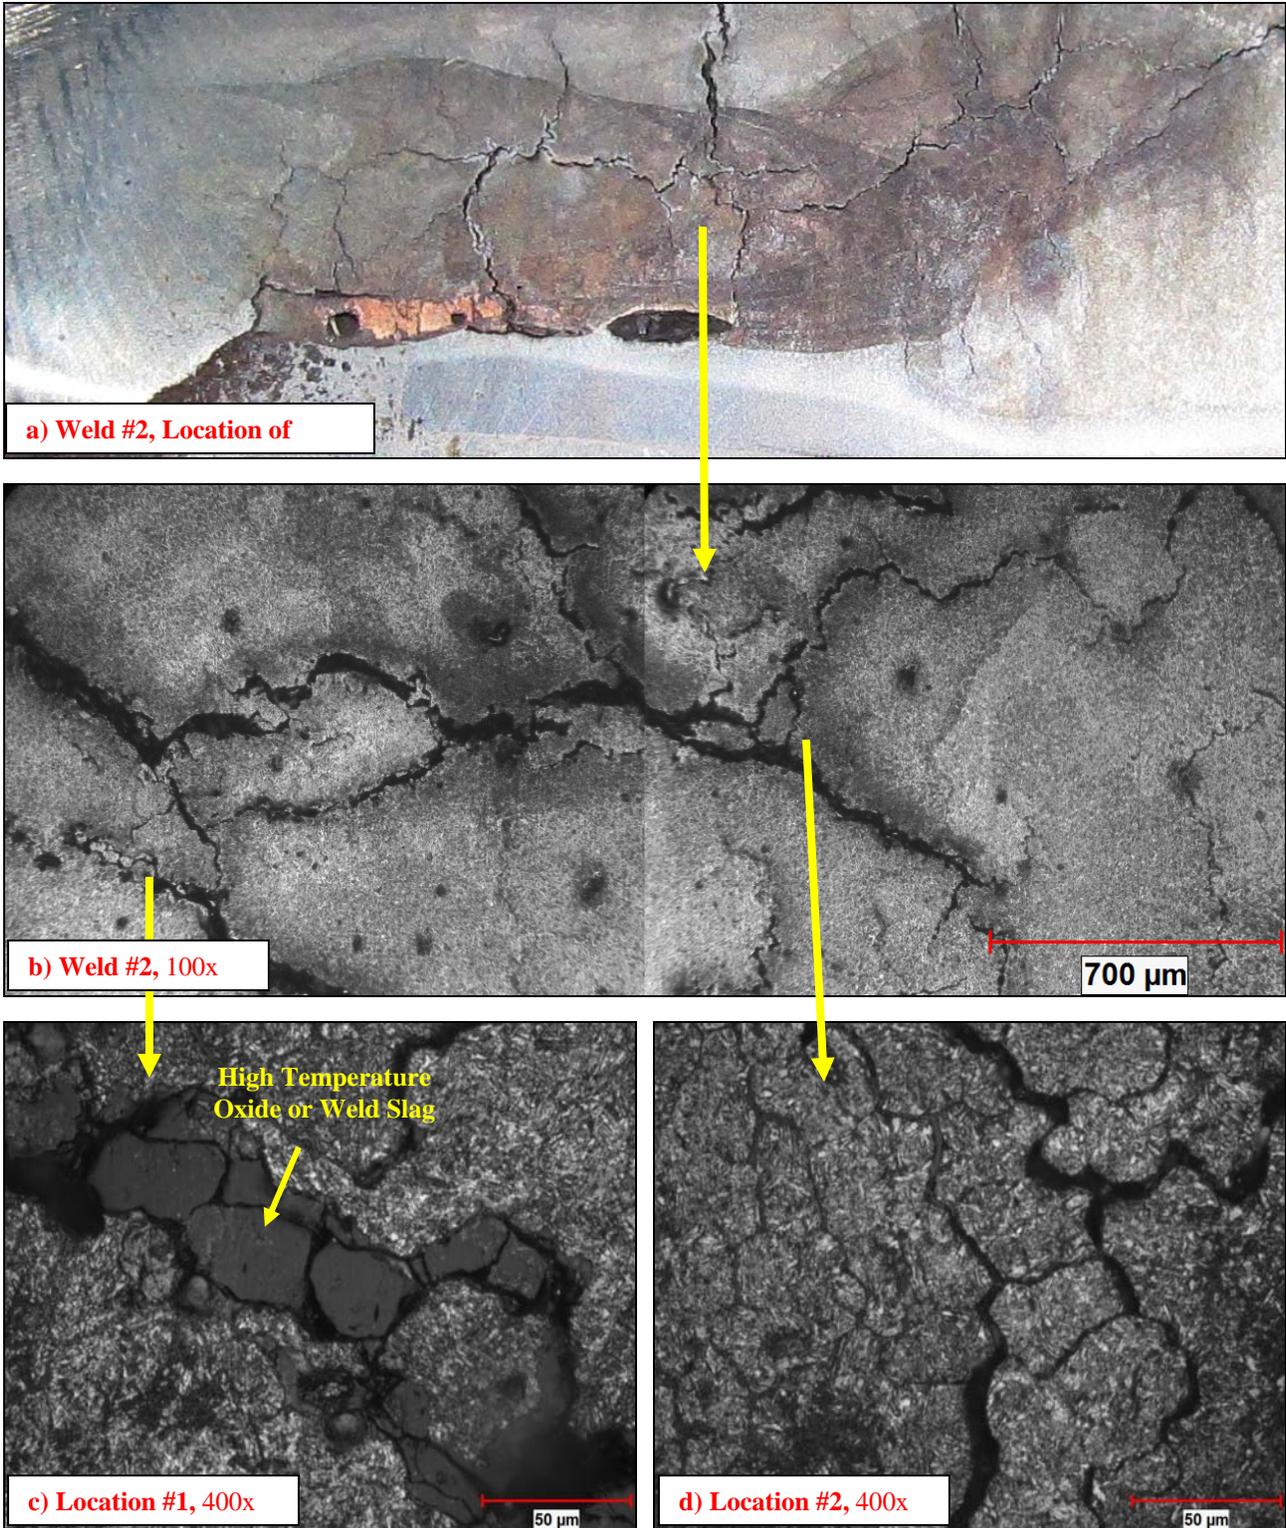
Figure 4: Micrographs displaying examples of the cracks and microstructure at Weld #2. The copper contamination had resulted in numerous hot tears during original welding. Images taken from replications, etched on-site using 3% nital.
