IN-SITU METALLOGRAPHY OF CRACKED CARBONATE REBOILER SHELL

EXAMPLE REPORT

IN-SITU METALLOGRAPHY OF CRACKED CARBONATE REBOILER CHANNEL

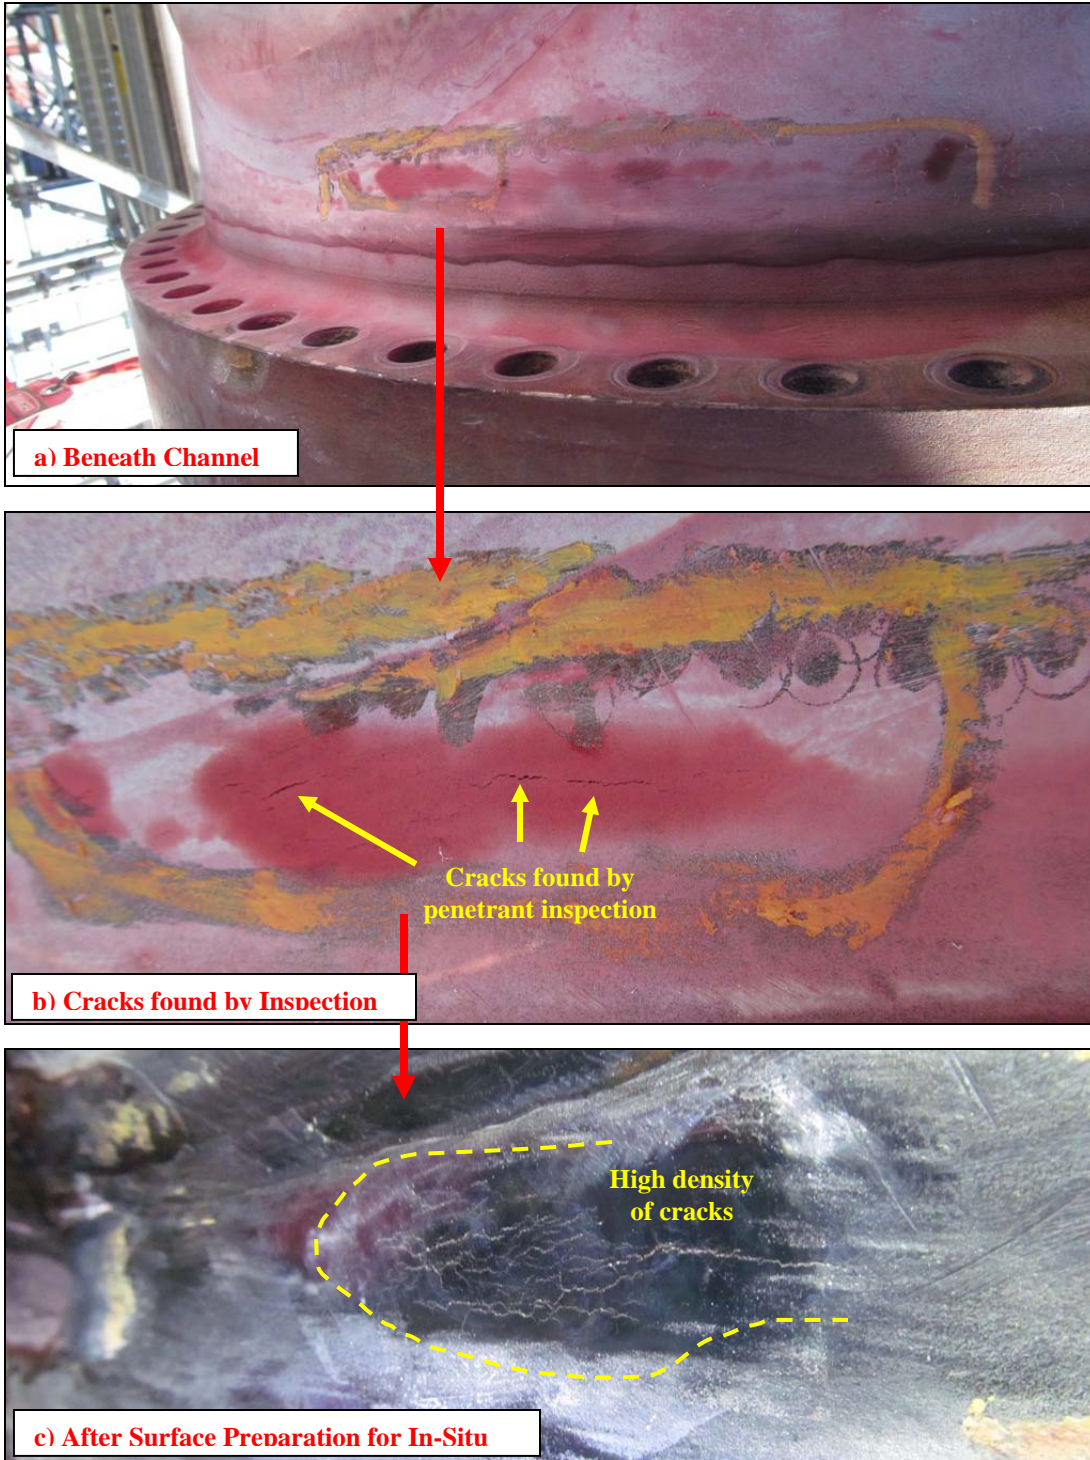
Figure 1a,b displays the indications found on the external surface adjacent the nozzle. The area of interest was lightly ground and polished to a 1 μ m finish. Replications were made in the as-polished and after electrolytically etching using 10% oxalic acid. After surface preparation and replication, the site near the nozzle was found to comprise of a high density of cracks. The severity and area of cracking was more extensive than first presented by penetrant inspection.

Figure 1: Photographs displaying the cracks on the external surface (a,b) as-found by penetrant inspection and (c) after surface preparation. The region comprised of a high density of cracks.

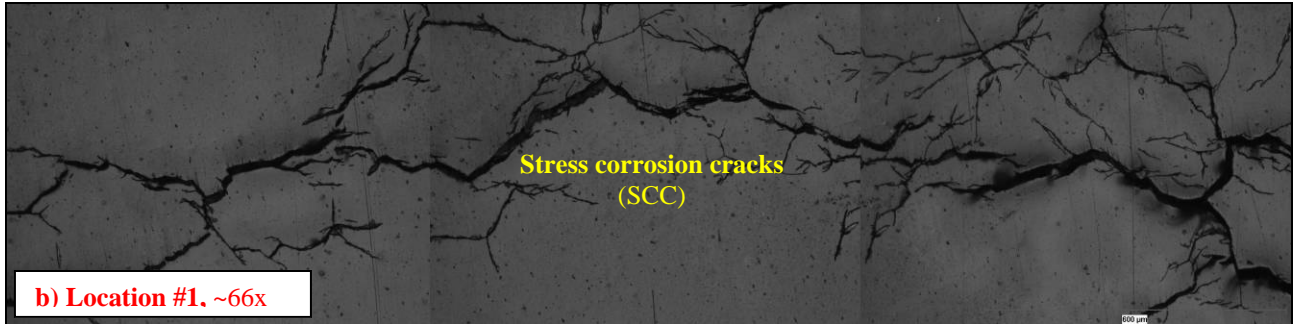
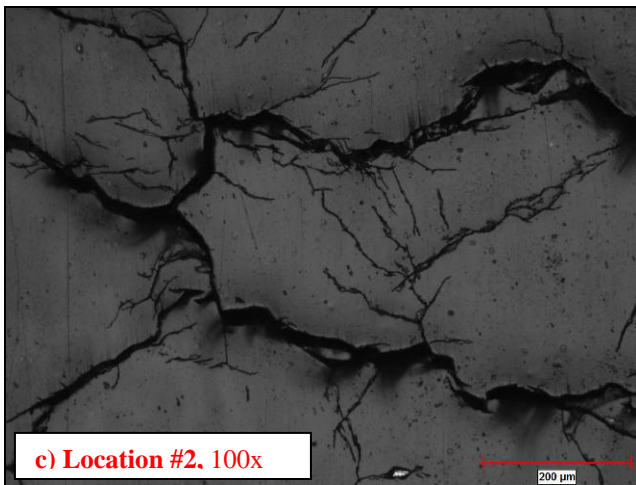
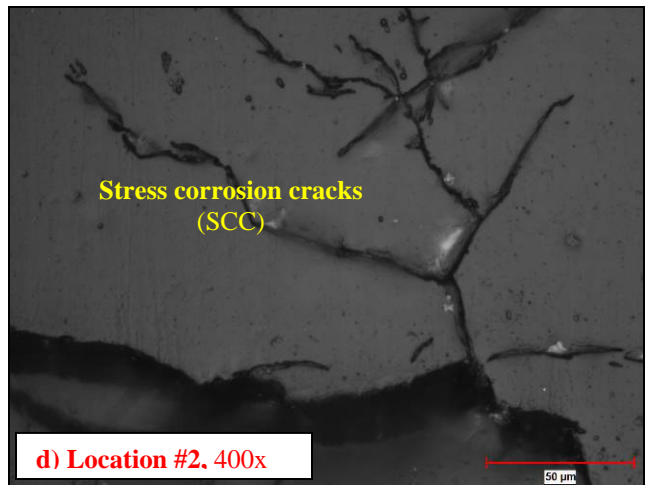
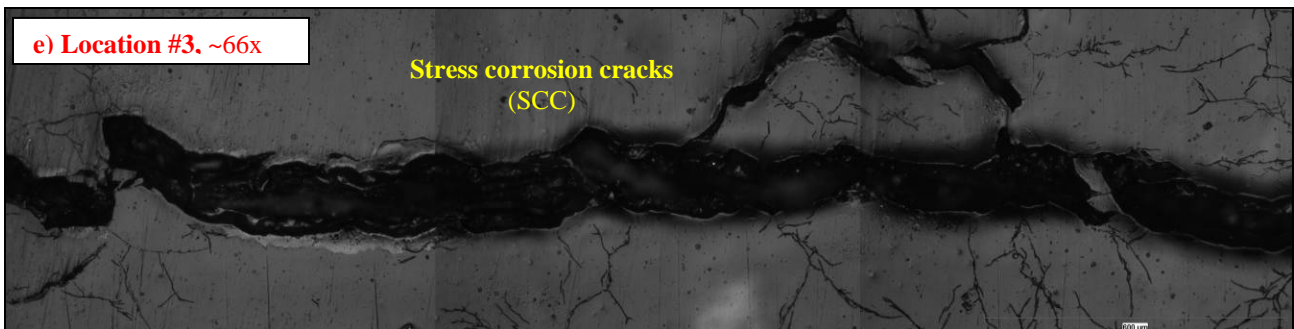
Optical examination of the replications found the networks of branched cracks to be consistent with stress corrosion cracking (SCC, **Figures 2 and 3**). The cracks tended to be transgranular in nature. Transgranular SCC cracking of 304 stainless steel is most often caused by aqueous chlorine/chlorides.

Figure 2: Micrographs displaying examples of the external cracks adjacent the nozzle. The branched nature of the cracks was consistent with stress corrosion cracking (SCC). The cracks were transgranular.

The external surface should have been dry and stress corrosion cracks indicated that copious amounts of water had been introduced over months if not years. Therefore, corrosion was consistent with corrosion under insulation (CUI). Images taken from replications.

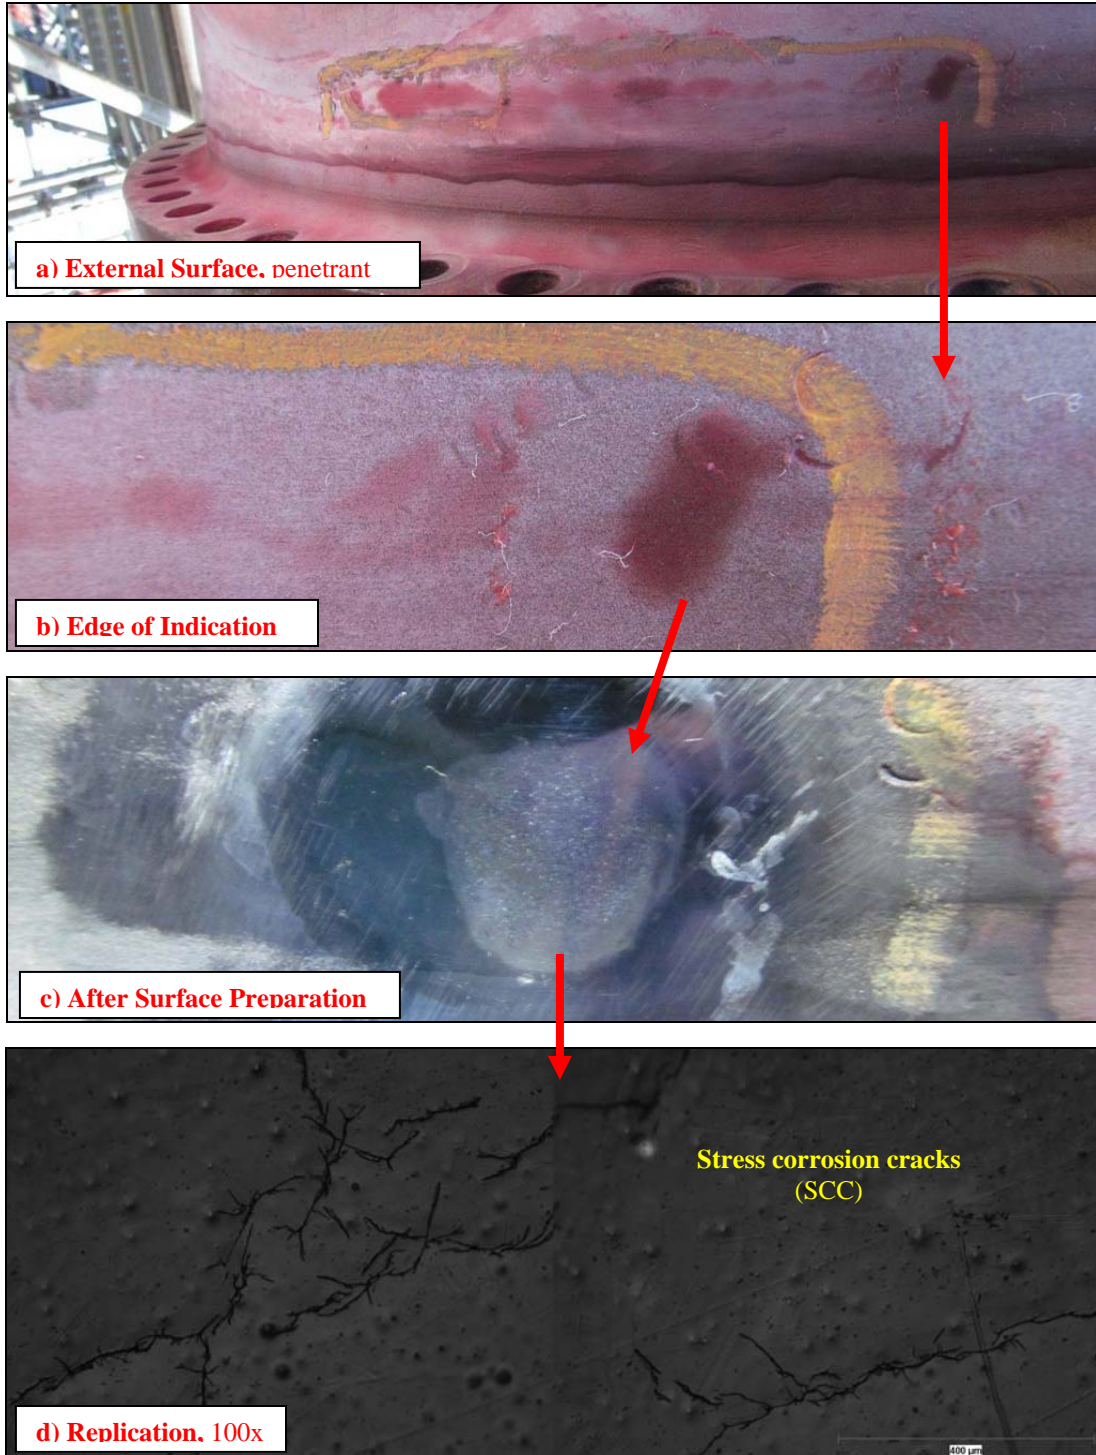
Figure 3: Photographs and micrograph of external cracks away from the nozzle, at the edge of the PT indication. Similar stress corrosion cracks were present at this location.
