FAILURE ANALYSIS OF MINE CONVEYOR SHAFT

EXAMPLE REPORT

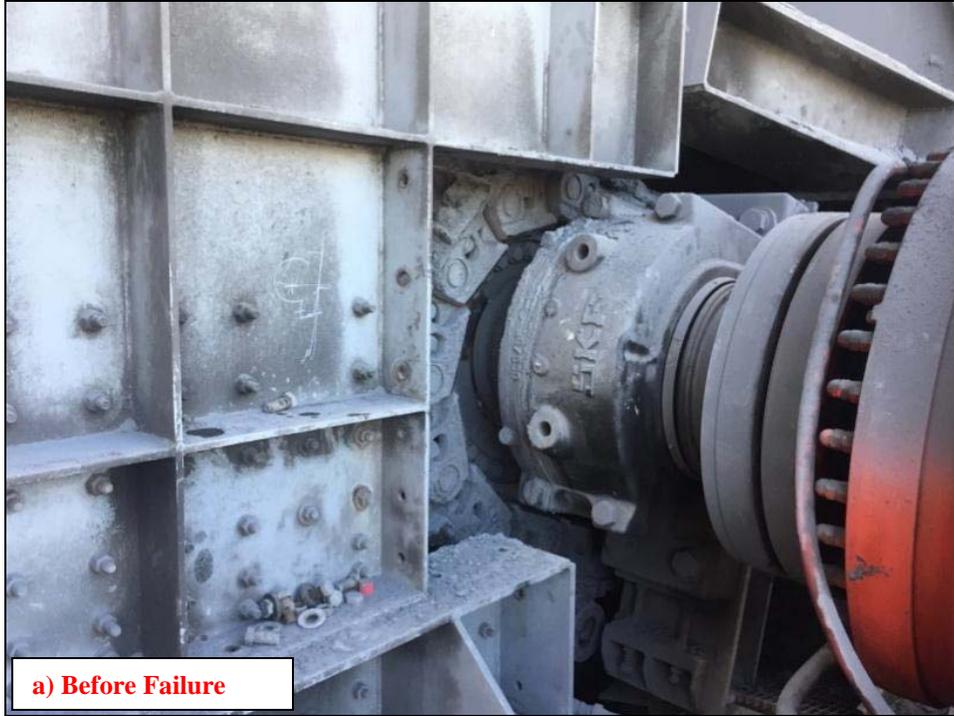
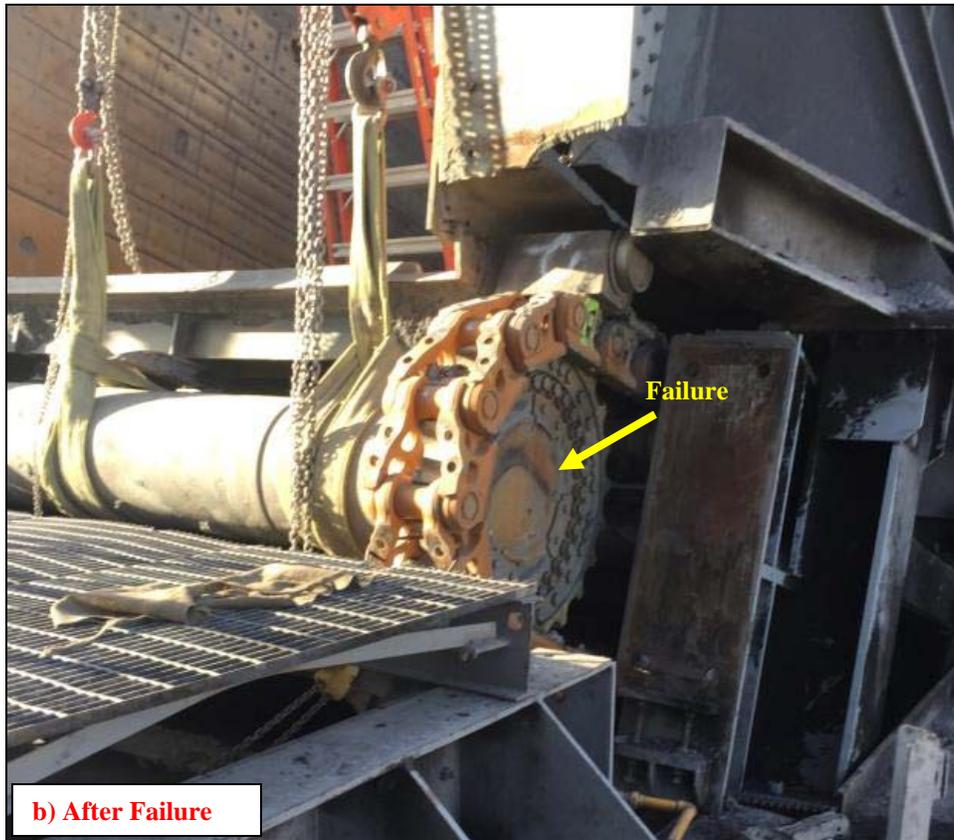
Figure 1: Photographs provided of the assembly (a) prior to failure and (b) after failure.

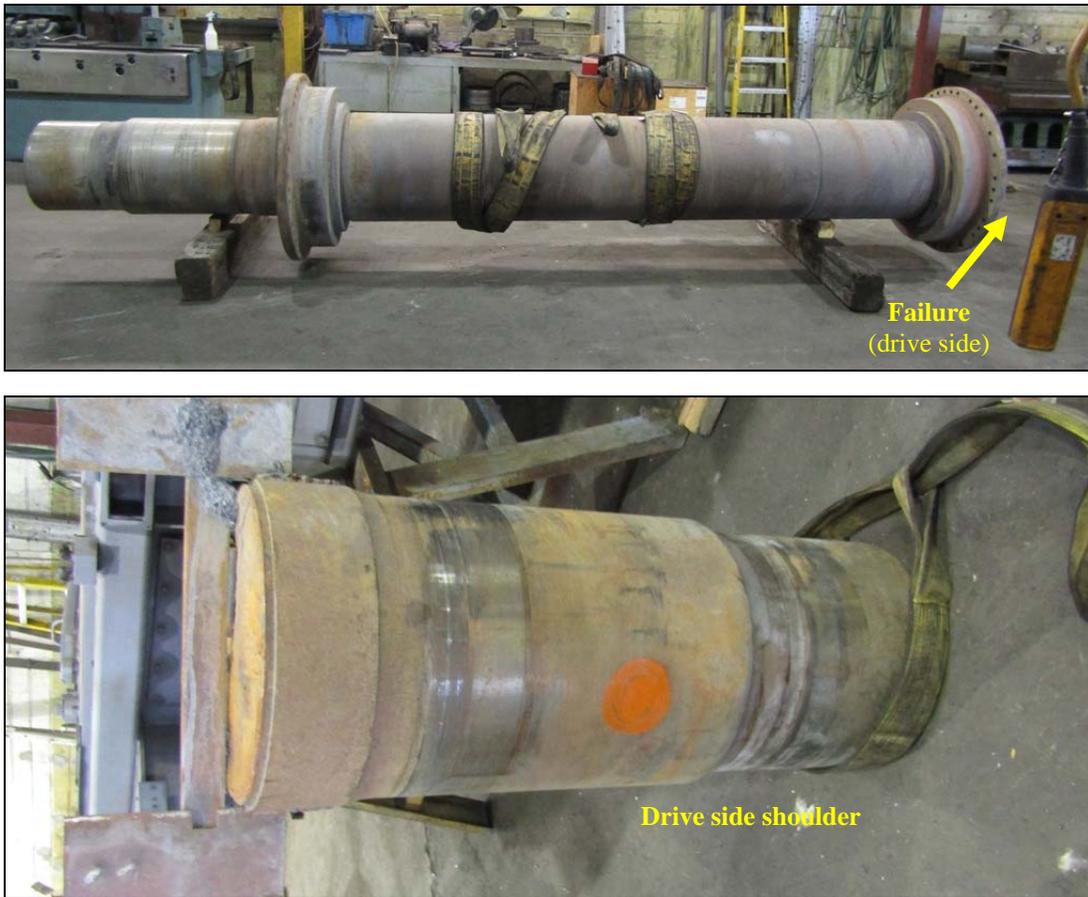
Figure 2 displays the submitted shaft. The drive side shoulder of the shaft had fractured off at the corner radius associated with the arm reduction in shaft diameter. **Figure 3a** displays the fracture surface as-received.

Figure 2: Photographs displaying the submitted shaft samples. The sprocket gears had been removed prior to submission.

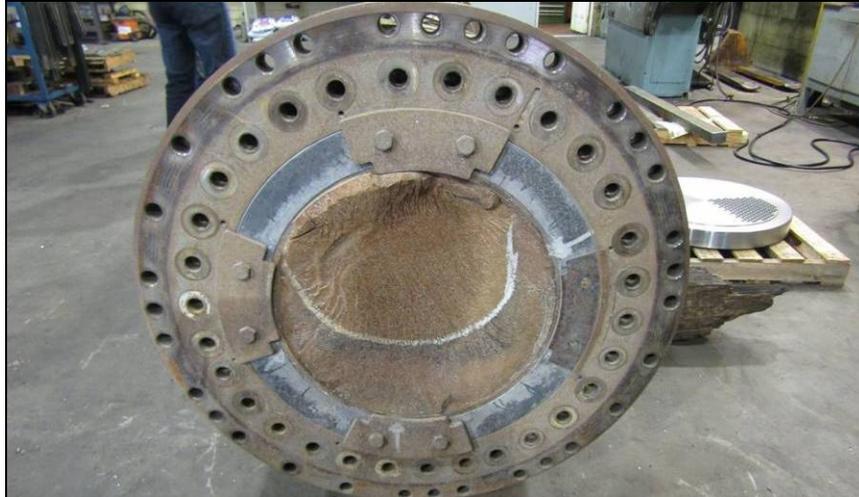
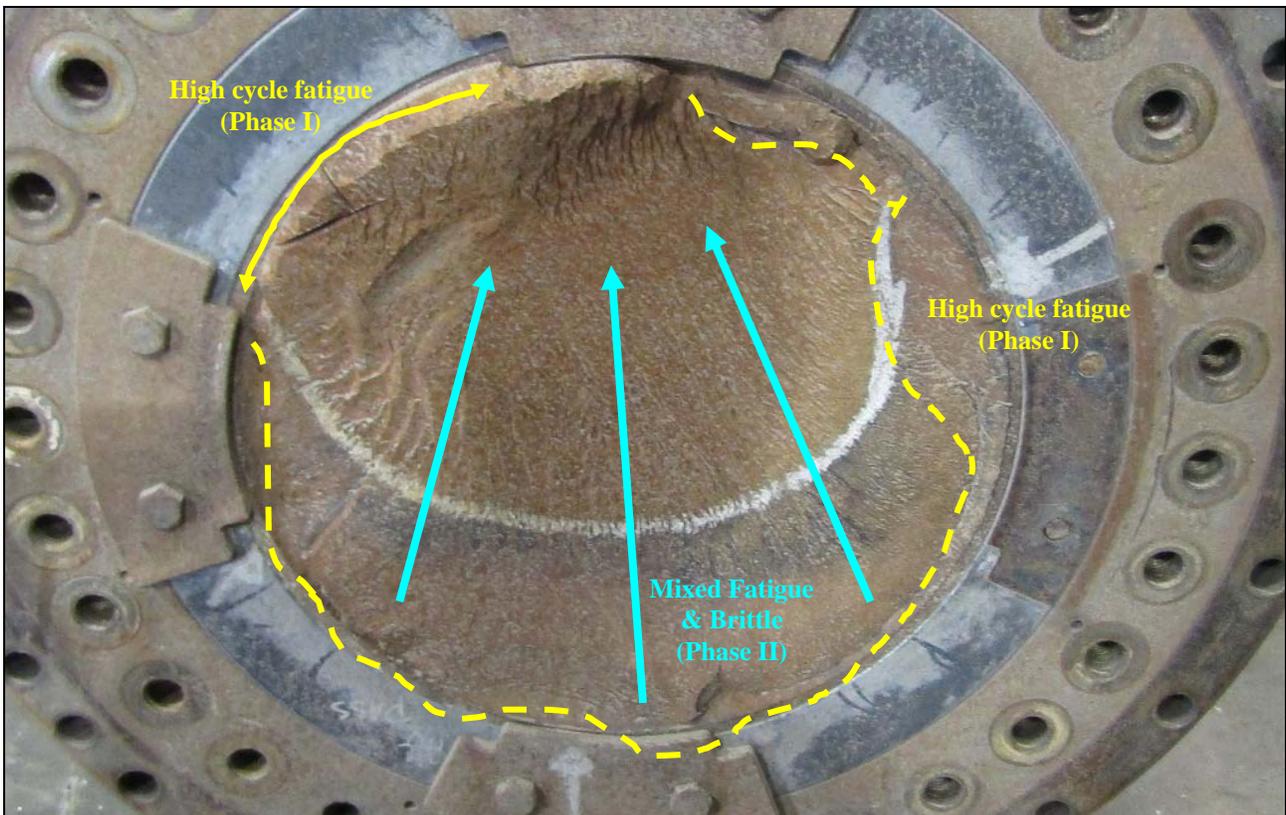
The shaft fracture region, plus the mirrored/opposite end of the shaft, was cut down in size to allow for cleaning of select regions of interest. Examination found that fracture had occurred during two different loading periods (**Figures 3b and 5**). The two phases of failure/loading can be described as:

Figure 3: Photographs displaying the shaft fracture. Analysis would find that failure had occurred in two phases.

Phase I – High cycle fatigue cracking had initiated around the shaft circumference. Associated with an alignment issue between the shaft and a non-rotating component (ie. such as a bearing, sprocket, drive chain, etc).

Phase II – Loading very different from initial, Phase I loading. This loading comprised of asymmetric side bending loading applied during shaft rotation (ie. misalignment of rotating component). Crack growth occurred by mixed fatigue and brittle fracture. Phase II was deemed as secondary damage after crack initiation during Phase I.

Note that had the shaft been inspected at the time of sprocket repair, such as by magnetic particle inspection (MPI), detection of the crack would have been probable and catastrophic failure likely prevented. It was unlikely that visual examination would have been able to reliably resolve the cracks at that time.

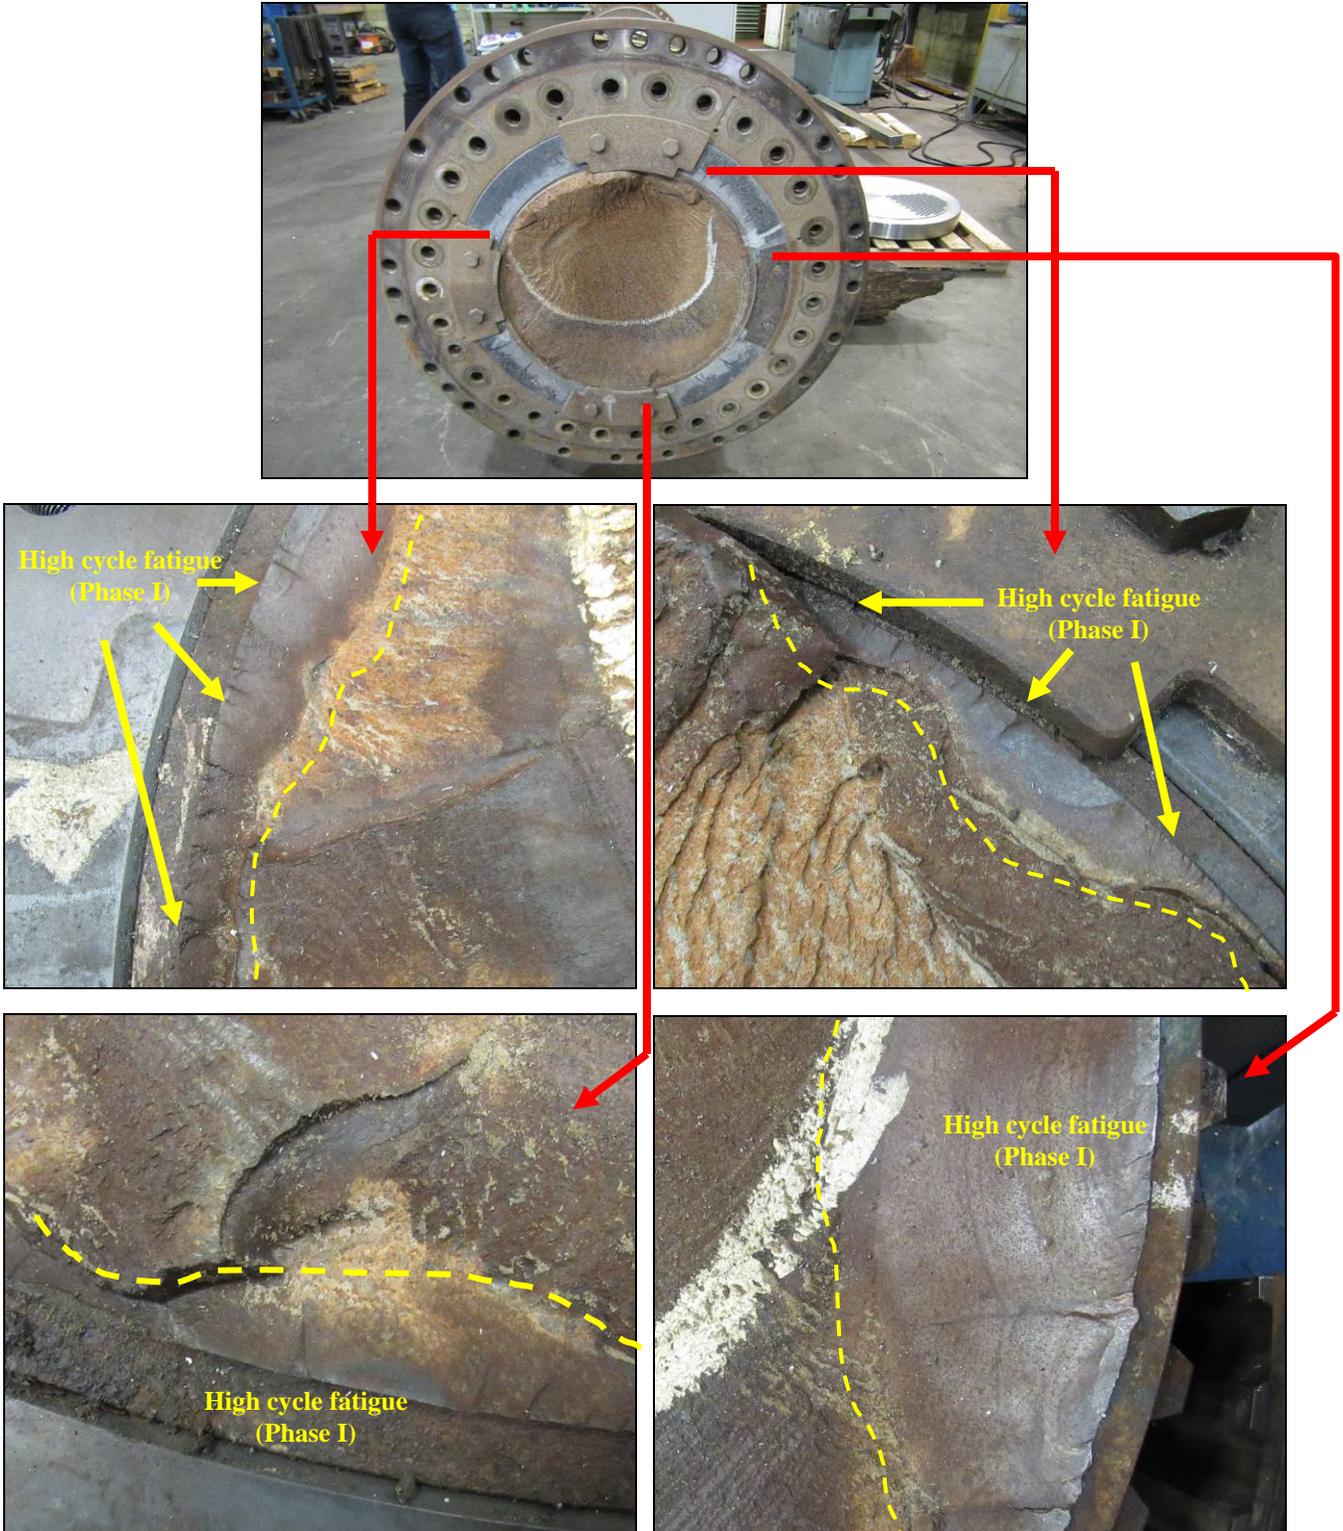
Phase I High cycle fatigue cracks had initiated around the majority of the shaft perimeter (**Figures 4 and 6c,d**). These cracks had grown to a depth of 2.5 inches. Fatigue cracks around the shaft perimeter indicated an alignment issue between the shaft and a non-rotating component within this area of the shaft (ie. bearing, sprocket, drive chain, etc).

It was noted that the shaft corner radius at the site of failure was relatively sharp, reducing the amount of misalignment/bending loading that the shaft could withstand prior to forming fatigue cracks. Further analysis/consideration of the corner radius is currently on-going. However, at this point in the investigation, the source of misalignment/bending loading appears to have been the primary cause of failure.

Figure 4: Photographs displaying high cycle fatigue cracks around the majority of the shaft circumference. These cracks had initiated at the corner radius associated with the reduction in shaft diameter.

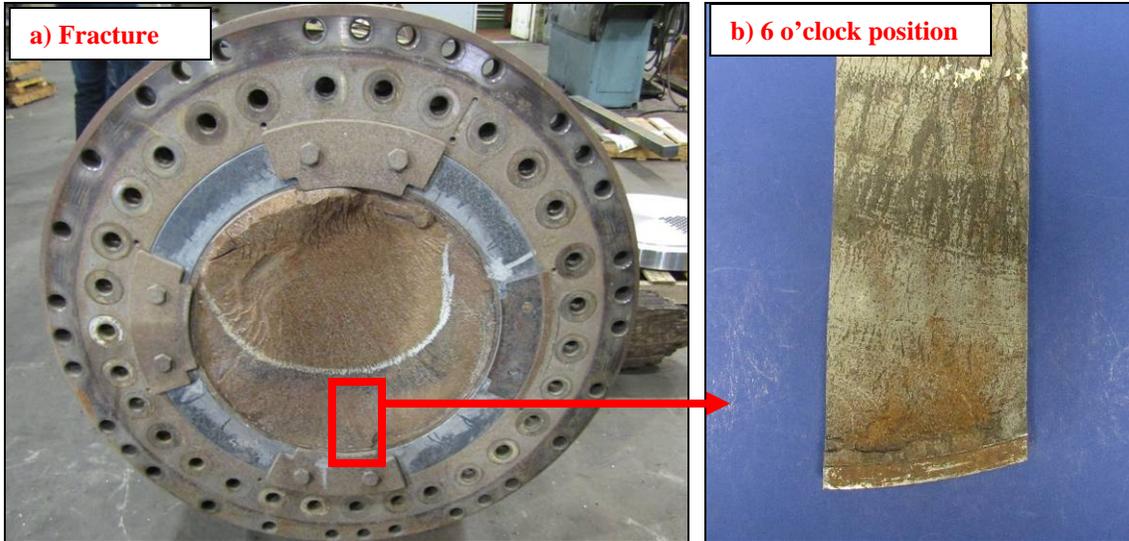
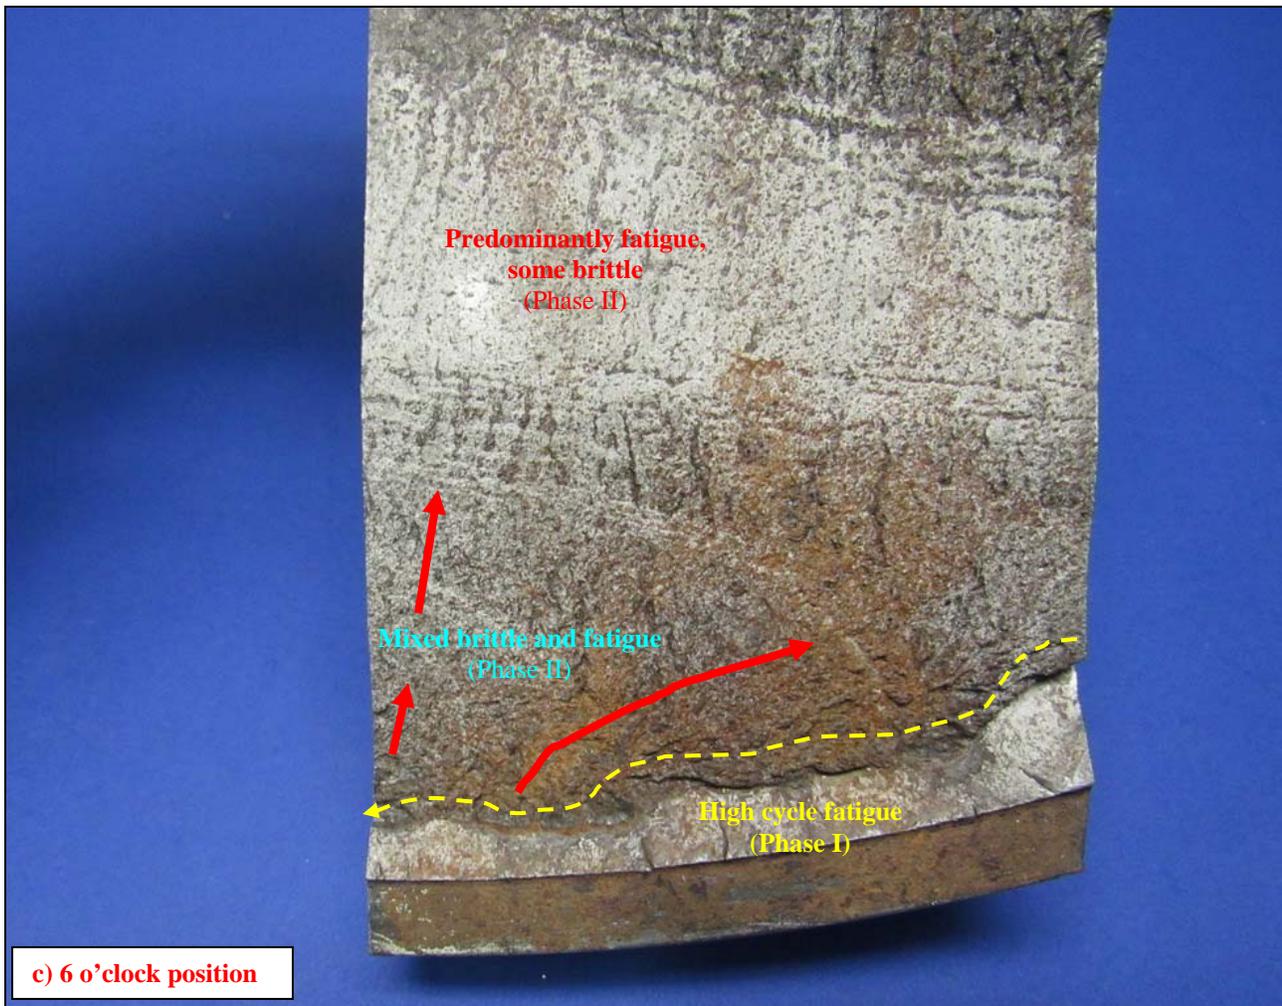
Phase II The loading responsible for Phase II was quite different from Phase I. Whereas the full perimeter of the shaft experiencing bending loading constantly as it rotating during Phase I, Phase II only experienced bending loading on one side during each revolution. Phase II transitioned between fatigue crack growth and brittle fracture (**Figures 6e,f and 7**). Thousands of fatigue cycles were observed between brittle fracture periods, suggesting occasional shock/impact loading during service.

Figure 5: Photographs illustrating the Phase I high cycle fatigue and the Phase II mixed fatigue/brittle fracture. The beginning of Phase II was dominated by brittle fracture before becoming predominantly fatigue crack growth.

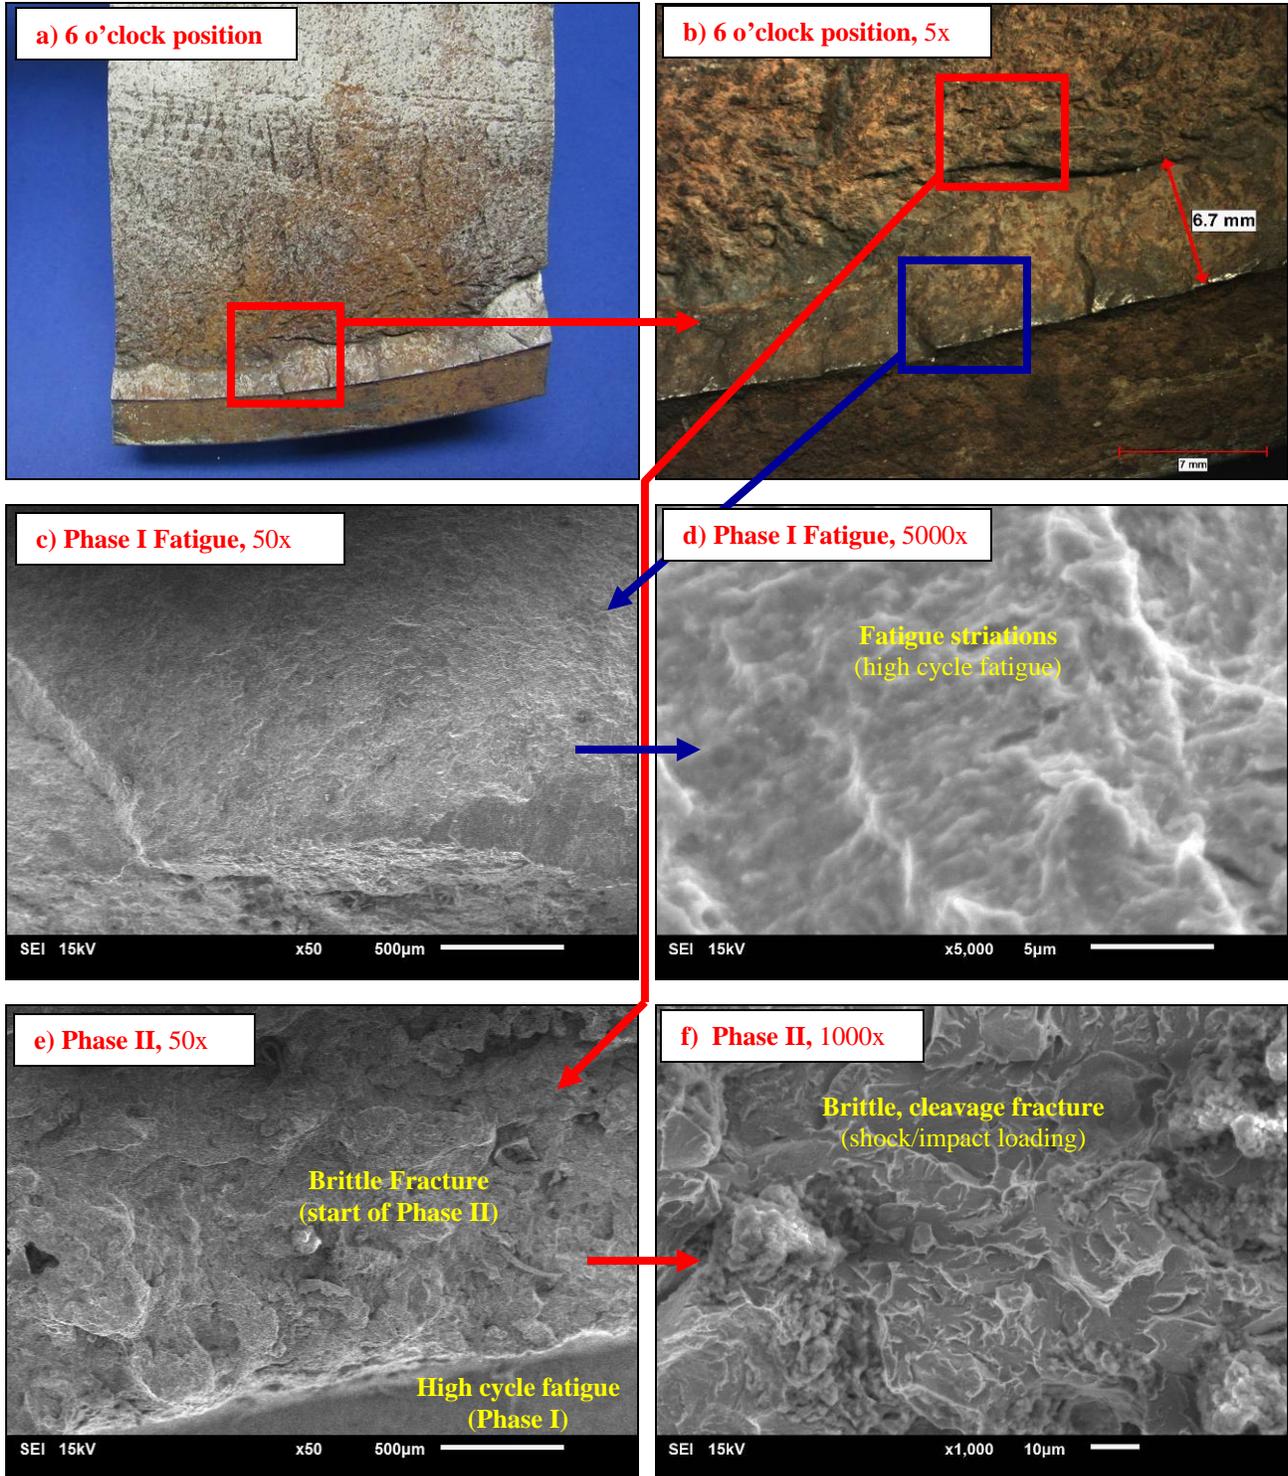
Figure 6: Photograph, macrograph and SEM images displaying (c,d) Phase I cracking had occurred by high cycle fatigue. (e,f) After high cycle fatigue, Phase II initiated by brittle fracture. Note again that the loading responsible for Phase II was quite different from Phase I, suggesting some adjustment/change had been made between phases (loading change suspected to correspond to re-installation of the repaired shaft in 2015). SEI, 15kV.

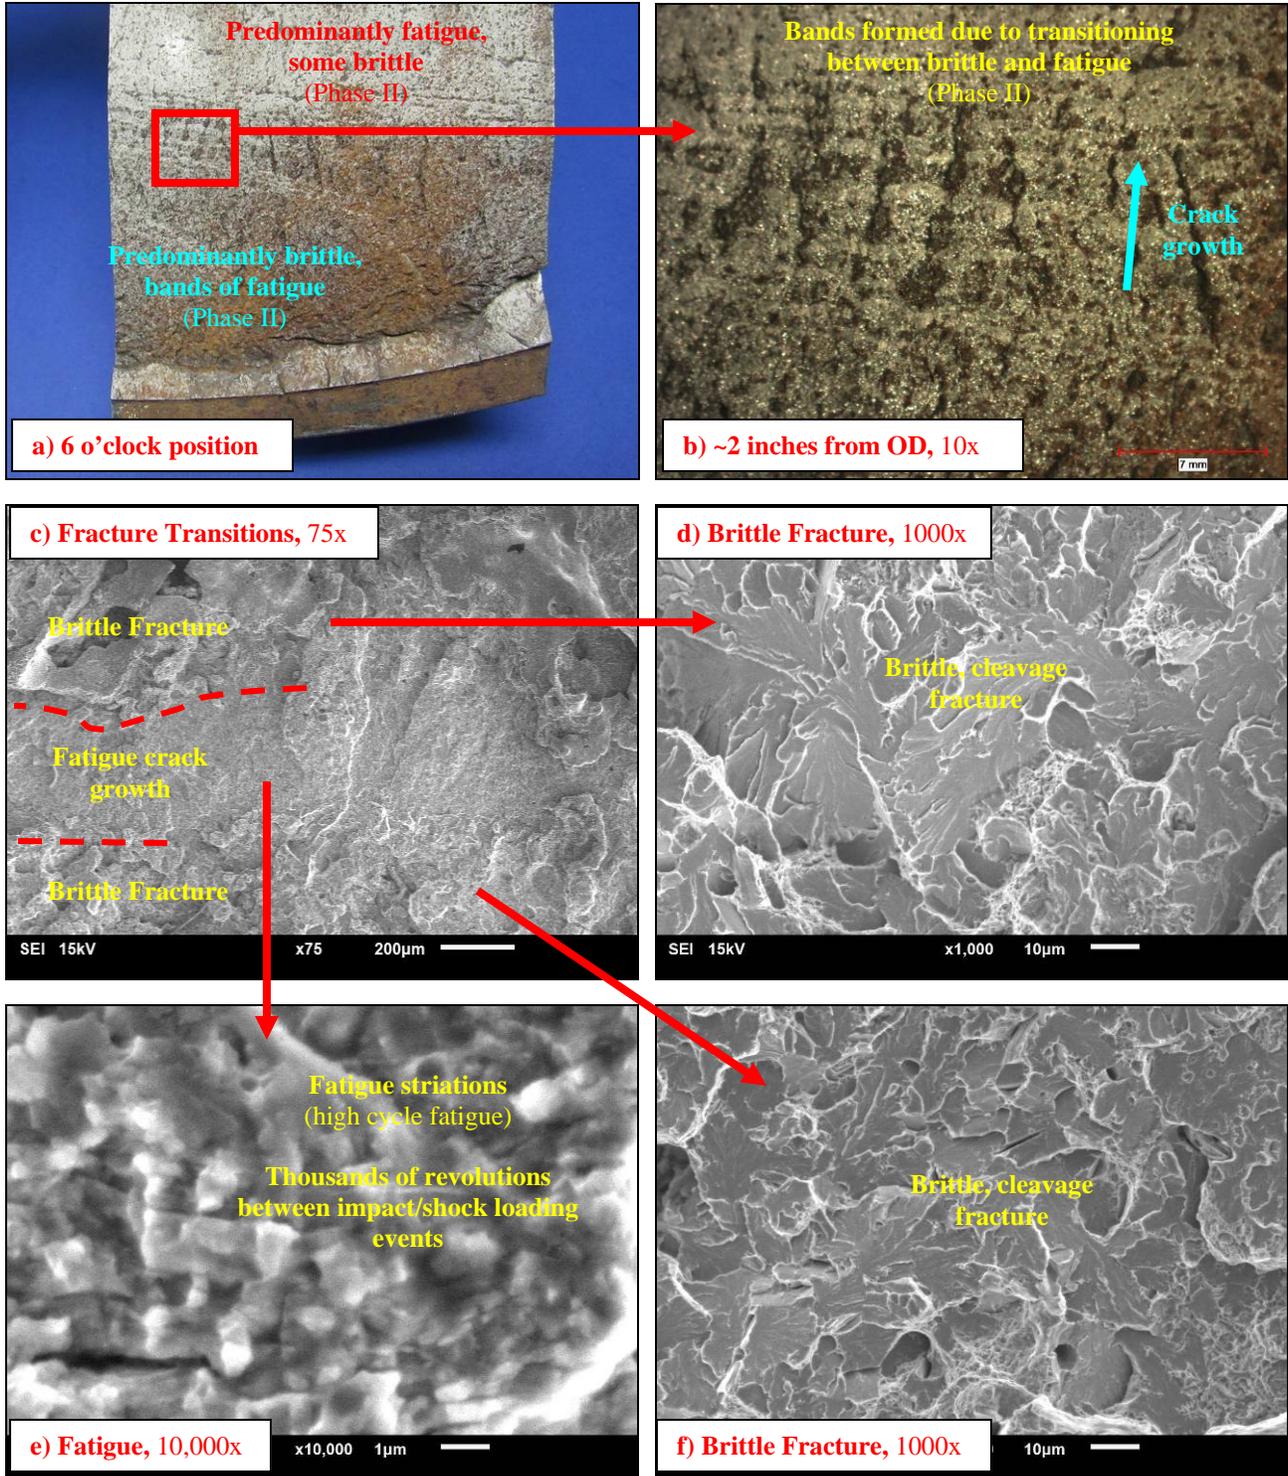
Figure 7: SEM images displaying the transitioning between brittle fracture and fatigue when the Phase II crack was approximately 2½ inches deep. This indicated that the shaft had experienced impact/shock loading, causing brittle crack growth, followed by periods of thousands of rotations before experiencing another impact/shock loading event. SE1, 15kV.
