INVESTIGATION OF A FAILED CHAIN LINK FROM AN AUTOMOTIVE ASSEMBLY PLANT

EXAMPLE REPORT

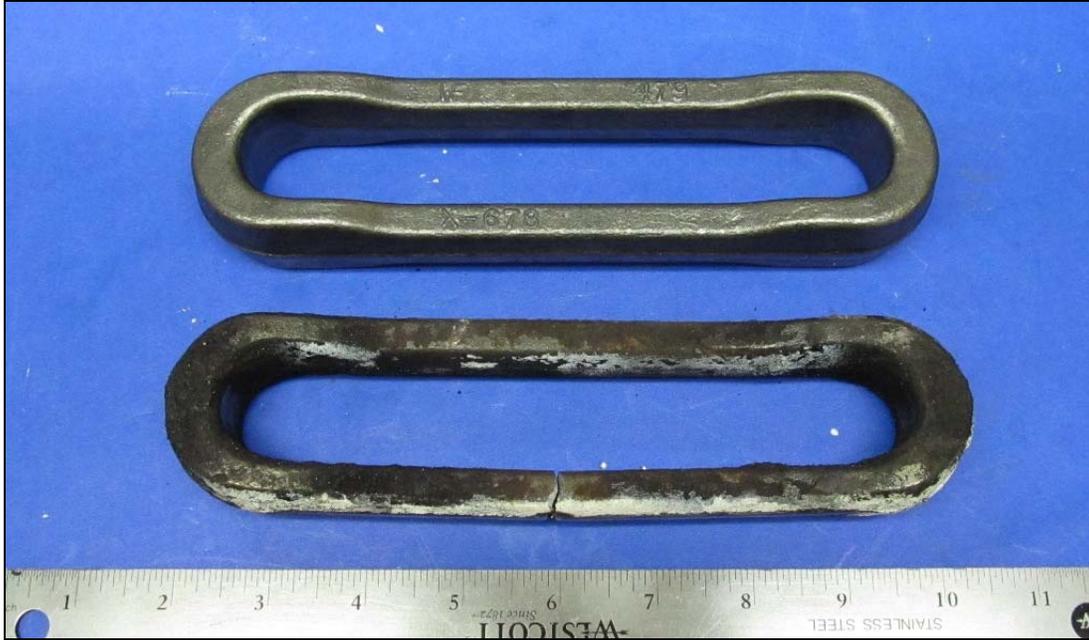
Figure 1 displays the two links in the as-received condition. The failed link was covered with baked grease and some portions of the link exhibited white paint. The fractured ligament displayed moderate yet superficial wear along its centerline. The link was ultrasonically cleaned using various solvents. **Figure 2** displays the link before and after cleaning.

Figure 1: Photograph displaying the two links submitted for the investigation.

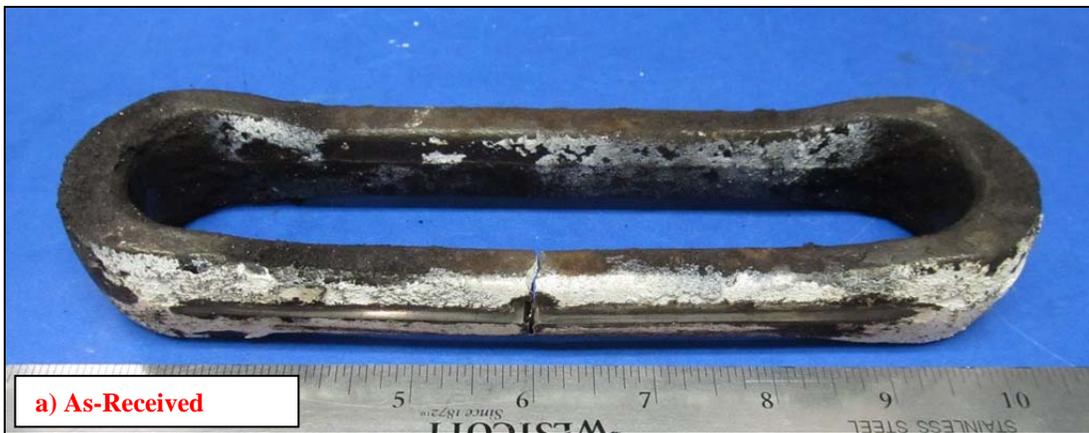
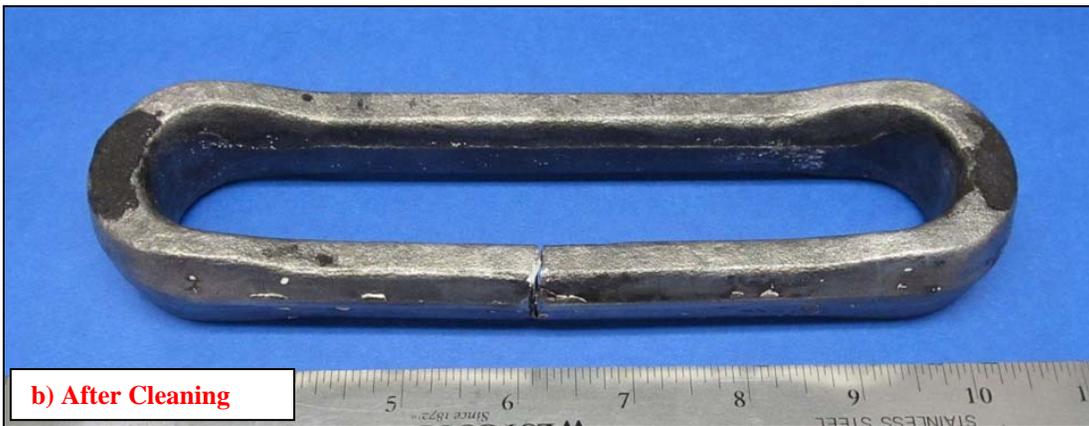
Figure 2: Photographs displaying the fractured link in the (a) as-received condition and (b) after cleaning.

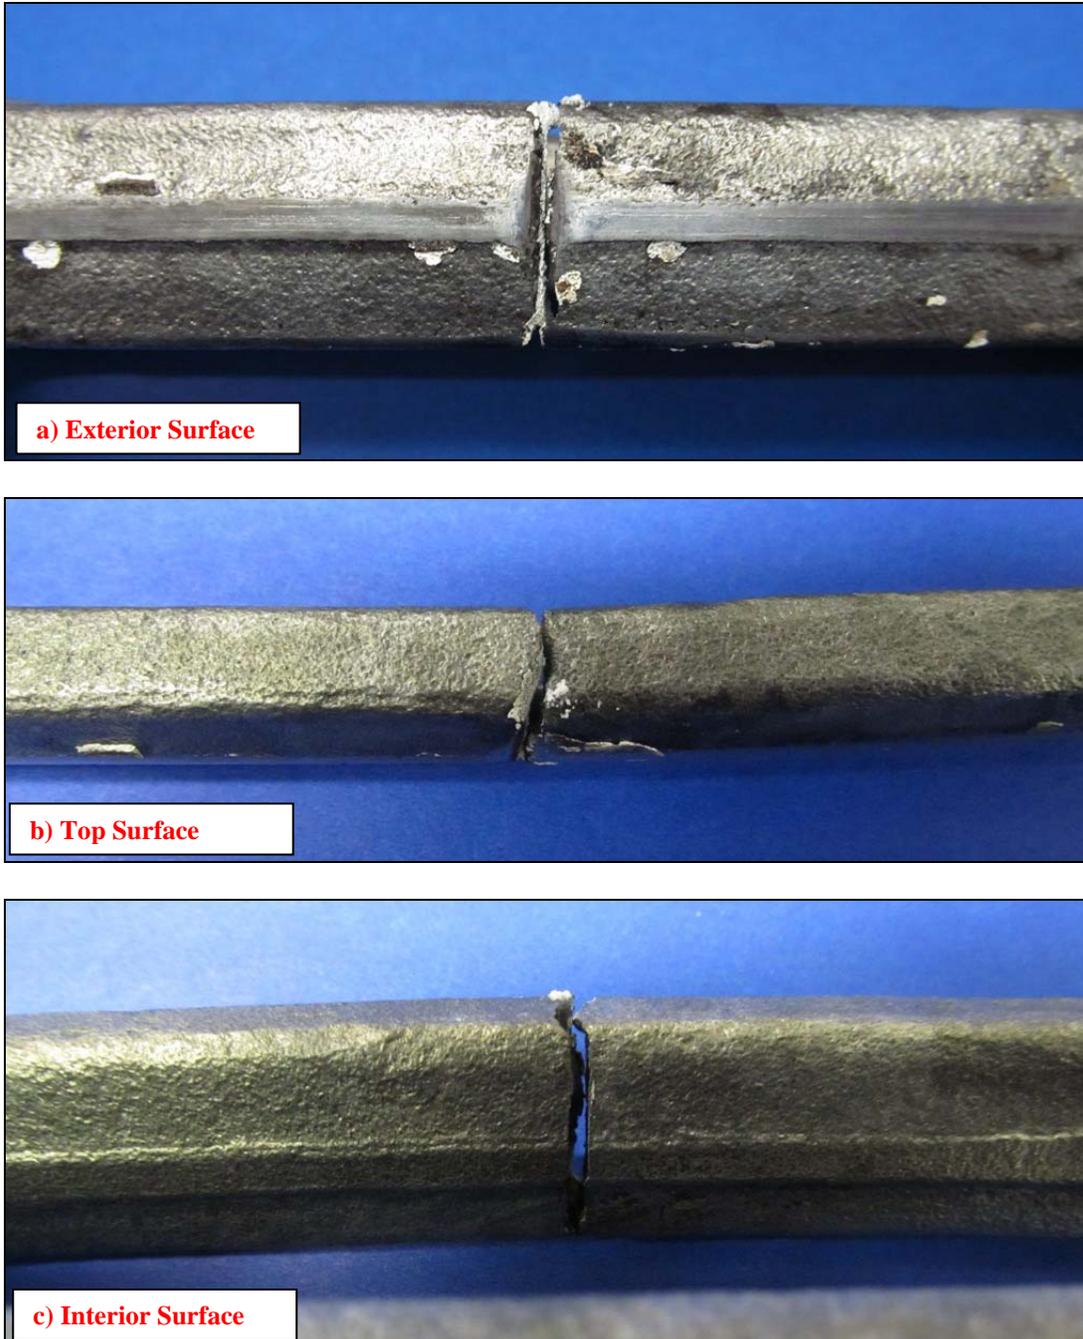
The fracture of one ligament had occurred at mid-length. Except for the formation of fine shear lips on the outer diameter surface, no deformation had occurred within the vicinity of fracture. The crack had opened up slightly due to deformation of the remaining ligament. **Figure 3** displays the fractured ligament.

Figure 3: Photographs displaying the fractured ligament.

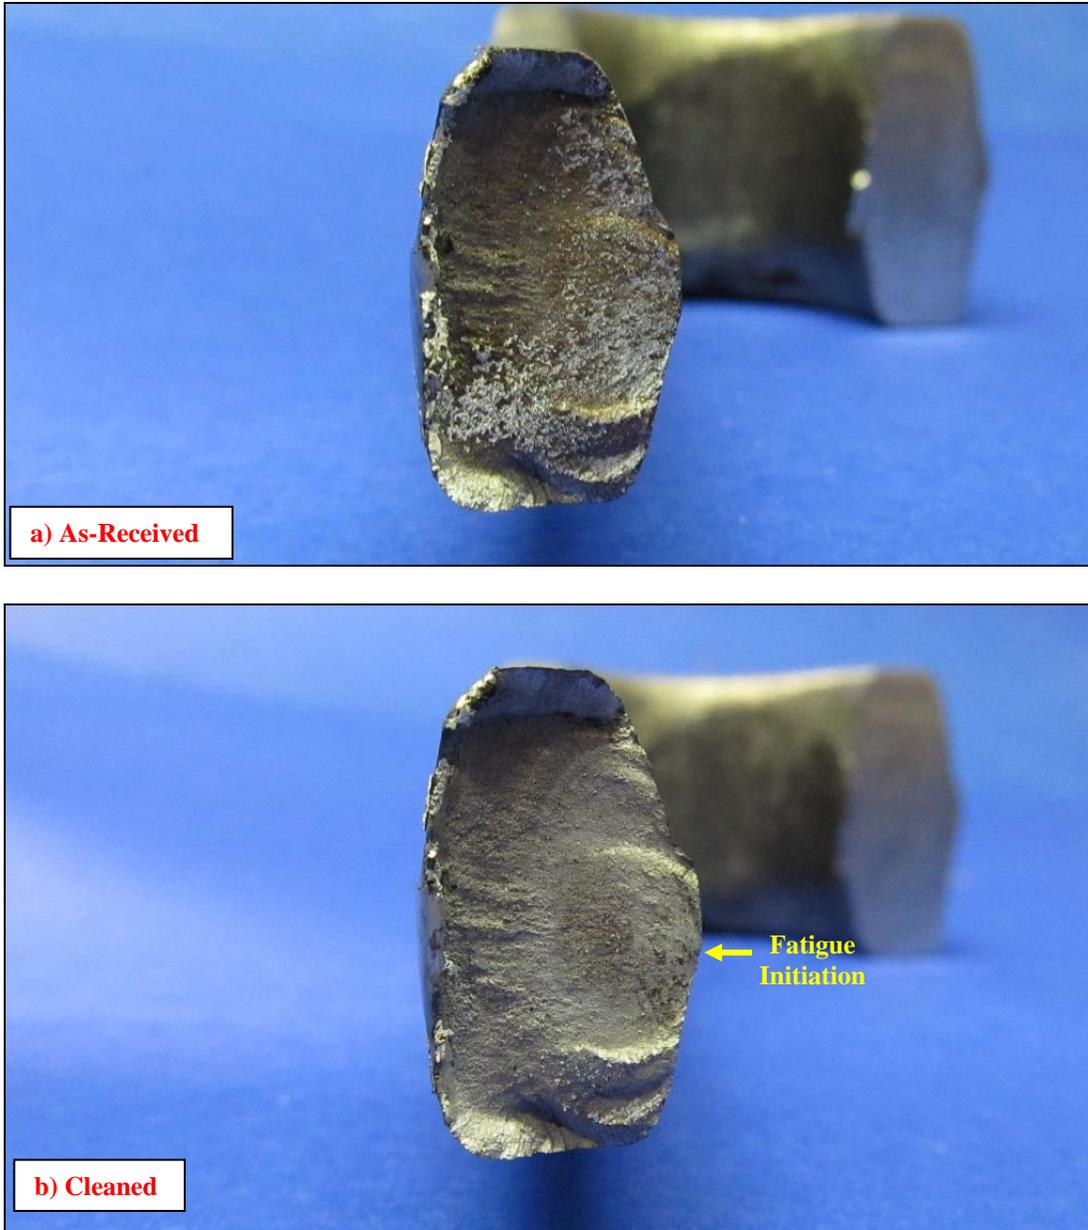
The link was cut in order to open up the fracture surfaces. One fracture surface exhibited a significant amount of white paint. The second surface comprised of less paint as illustrated in **Figure 4a**. This half of the fracture was ultra-sonically cleaned for fractography. **Figure 4b** displays the cleaned fracture surface.

The fracture features were consistent with fatigue fracture. Fatigue crack initiation had occurred at a single location along the inner diameter surface. **Figures 4b and 5a,b** indicate the location where the crack had begun from. The crack had initiated at a forging flaw. The forging flaw was measured to extend 0.10 inches (2.6mm) into the fracture. Further examination would find that only the initial 0.016 inches (0.4mm) portion of the flaw had contributed for crack initiation.

The first third of the fracture surface exhibited a flat morphology with crack arrest marks typical of high-cycle fatigue (ie. repetitive low-to-moderate stresses). At this point, the fracture gradually transitioned and the remaining two-thirds of the fracture exhibited bands from low-cycle fatigue low crack growth. Low cycle fatigue indicated the loading experienced by the fractured ligament had been relatively high compared to the material strength. The outer perimeter of the fracture exhibited shear lips from final failure.

Figure 4: Photographs of the fracture surface in the (a) as-received and (b) cleaned conditions. The fracture exhibited fatigue features radiating from a single point.

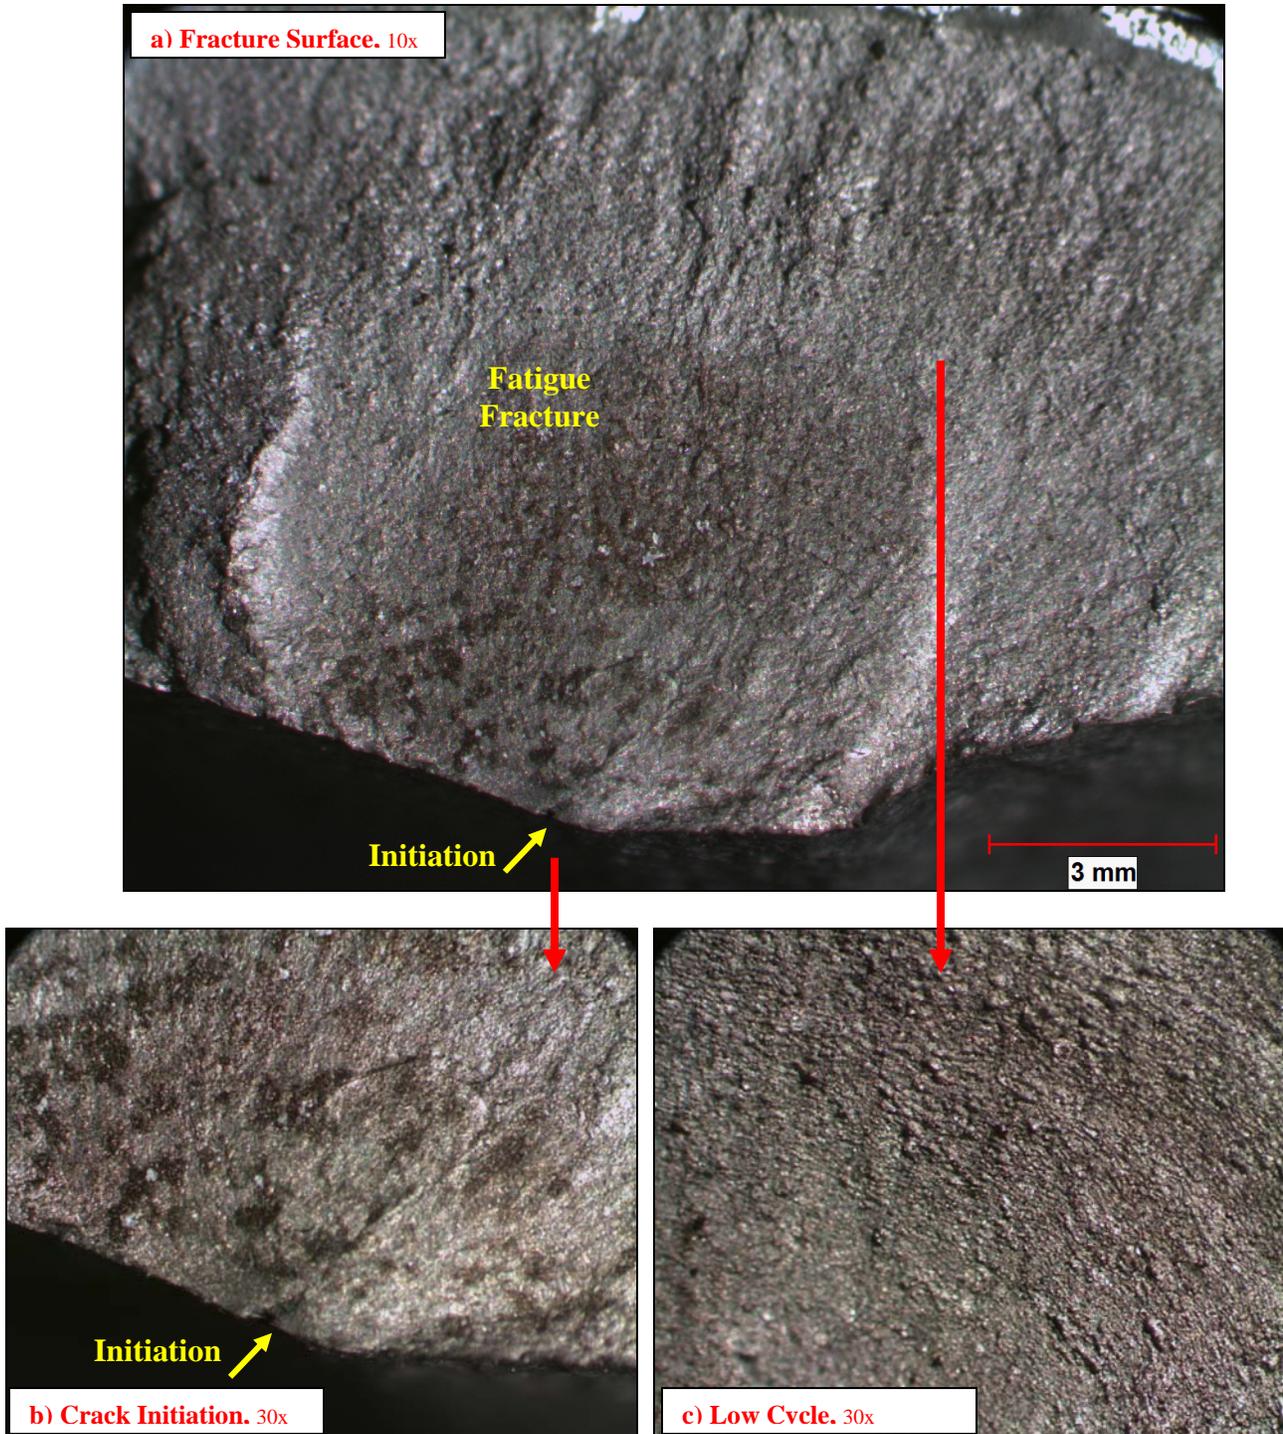
The presence of a small forging flaw was not considered a significant contributor to failure. Only the mouth of the forging flaw, measuring 0.016 inches (0.4mm) in depth, had provided a stress concentrator. Flaws of this size are common for forged links and the design safety margin would readily account for such small features. Therefore, this flaw was deemed as a convenient site for fatigue initiation to occur under elevated loading rather than the cause of failure.

Figure 5: Macrographs displaying the fracture surface. The fracture features were consistent with fatigue failure from repetitive loading. Crack initiation had begun at a forging flaw yet further analysis would find that this small feature had not been a significant contributor to failure.

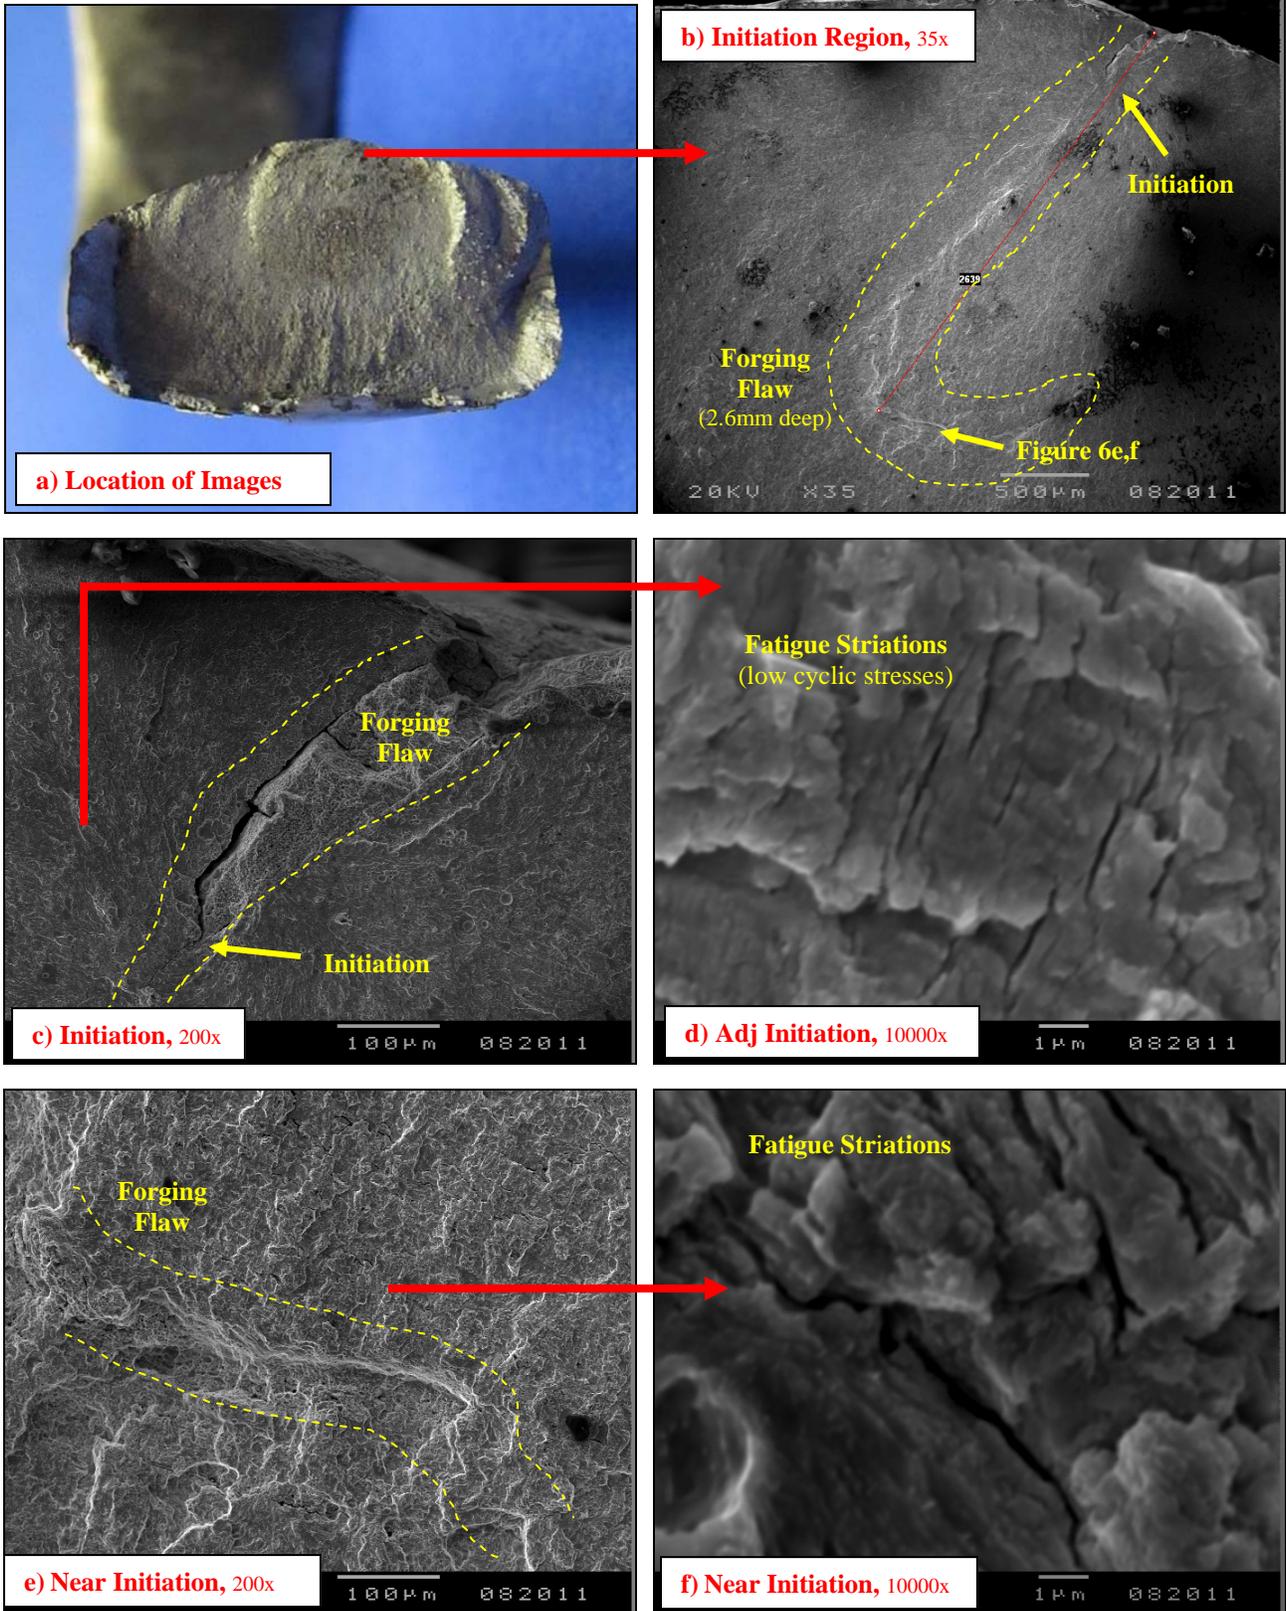
The cleaned fracture surface was examined at high magnification using a scanning electron microscope (SEM). Examination of the initiation region confirmed that the fatigue fracture had begun at the forging flaw. Crack initiation had occurred at the 0.016 inches (0.4mm) deep mouth of the flaw (**Figure 6b,c**). Note that such a small flaw would not have provided a significant stress concentration effect.

Crack initiation and initial propagation had occurred by high-cycle fatigue cracking as indicated by the fatigue striations (**Figure 6d**).

Note that after initiation at the forging flaw tip, the remainder of the forging flaw had not influenced crack growth. **Figure 6e,f** shows the flaw having had no effect upon the behaviour of crack propagation. This was due to the orientation of the flaw being longitudinal to the ligament whereas the crack had propagated in the transverse orientation.

Figure 6: SEM images displaying fatigue striations classic for fatigue failures. Crack initiation had occurred at the 0.016 inches (0.4mm) deep mouth of a forging flaw. SE1, 15kV.

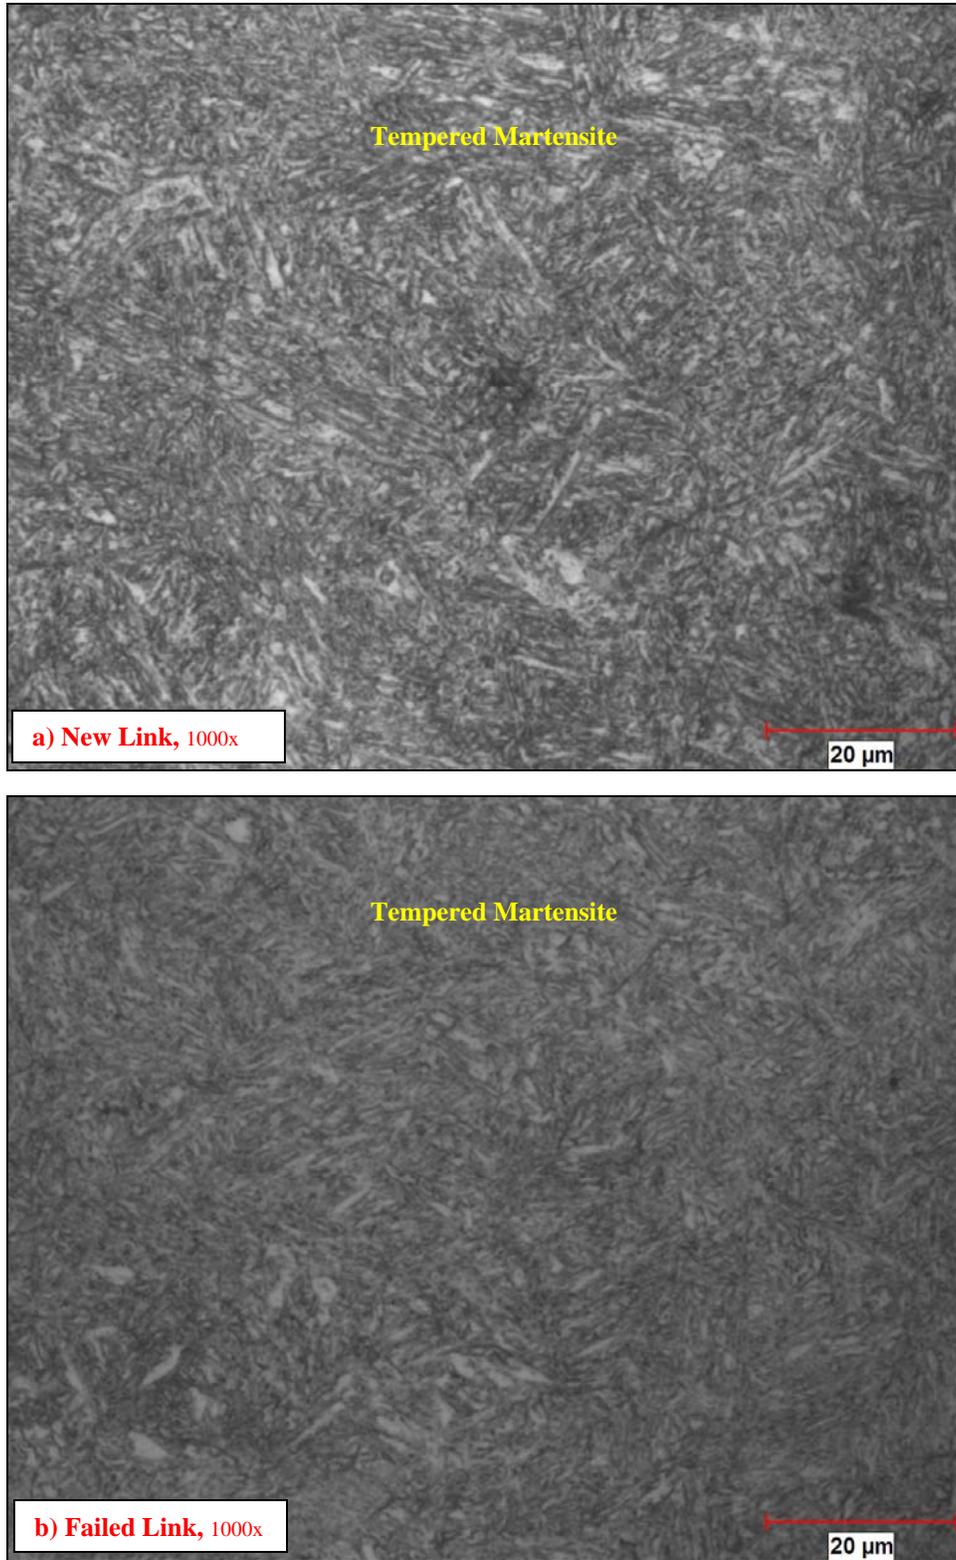
The new and failed links were transversely cross-sectioned through the ligaments and prepared for metallographic evaluation in accordance with ASTM E3. The cross-section on the failed link was taken ~6mm (~0.25 inches) from the fracture. Optical examination found both links to comprise of a tempered martensitic structure typical of a hardened alloy steel. The failed link appeared slightly more tempered than the new link however, it was still within the typical condition expected for such an application. **Figure 7** displays the core structure of the two links.

Figure 7: Micrographs displaying the core structure of (a) the New Link and (b) the Failed Link. Both links exhibited tempered martensitic structures typical for such links. Etched using 3% nital.

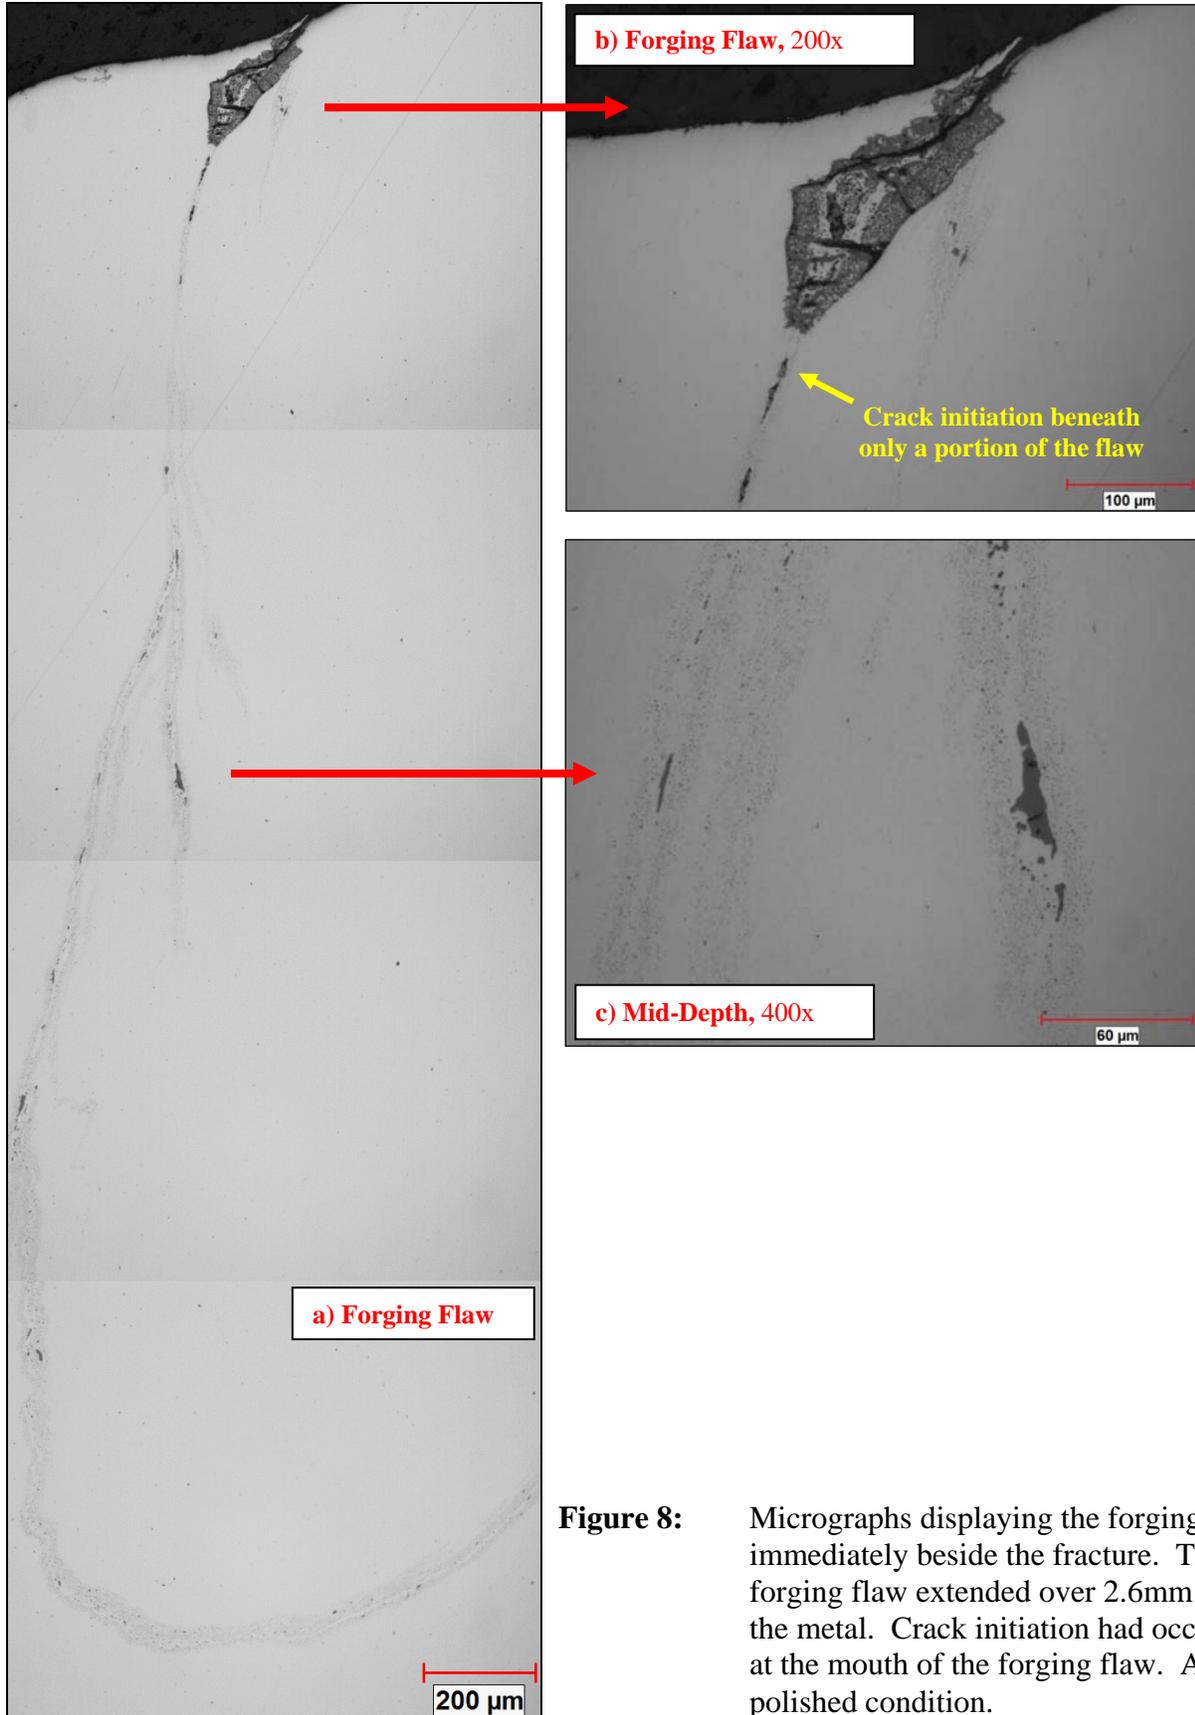
As observed on the fracture surface, the cross-section of the failed link consisted of a large forging flaw. **Figure 8** displays the forging flaw and **Figure 8b** displays the location corresponding to crack initiation.

Figure 8: Micrographs displaying the forging flaw immediately beside the fracture. The forging flaw extended over 2.6mm into the metal. Crack initiation had occurred at the mouth of the forging flaw. As-polished condition.
