Steel Image Inc., Failure Analysis and Metallography  
7 Innovation Drive, Suite 155, Flamborough  
Ontario, Canada, L9H 7H9, (289) 895-8363

# FAILURE ANALYSIS OF GRADE 12.9 BOLTS

## EXAMPLE REPORT

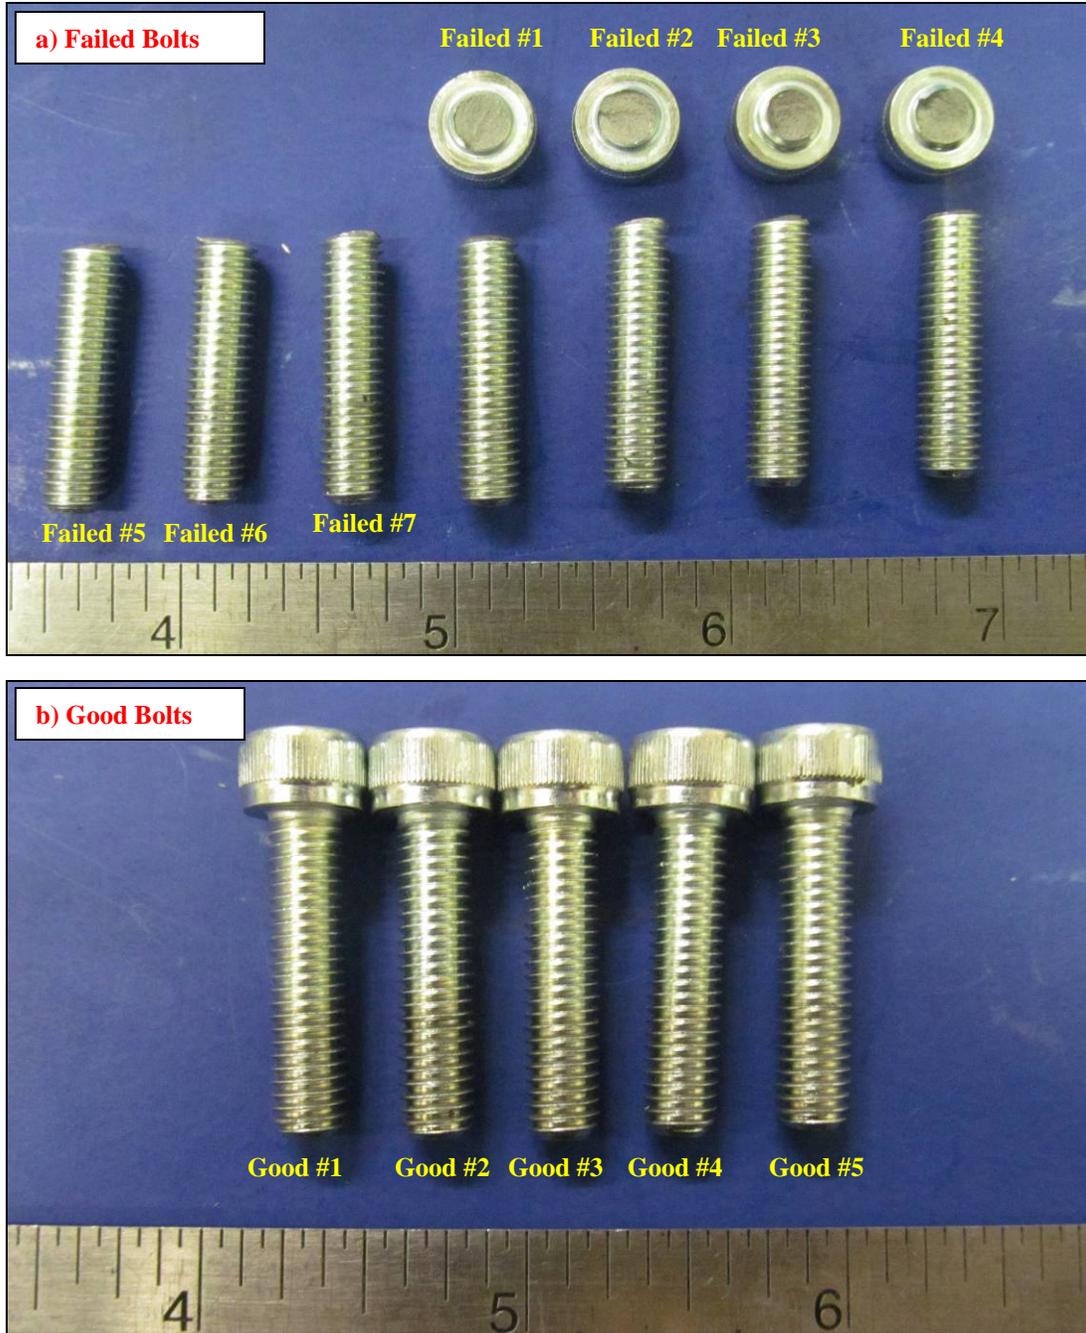
**Figure 1** displays the twelve bolts, comprising of seven failed and five good bolts, submitted for analysis. Fracture of the failed bolts had all occurred between the bolt head and shank (**Figure 2**). Stereoscopic examination found the fracture surfaces to be shiny and lacking in deformation, typical of brittle fracture. Some of the heads demonstrated a shear lip, associated with final failure.

**Figure 1:** Photographs displaying the twelve bolt samples submitted for analysis. These included parts of seven failed bolts and five good bolts, which had been located on either side of the failed bolts during assembly.

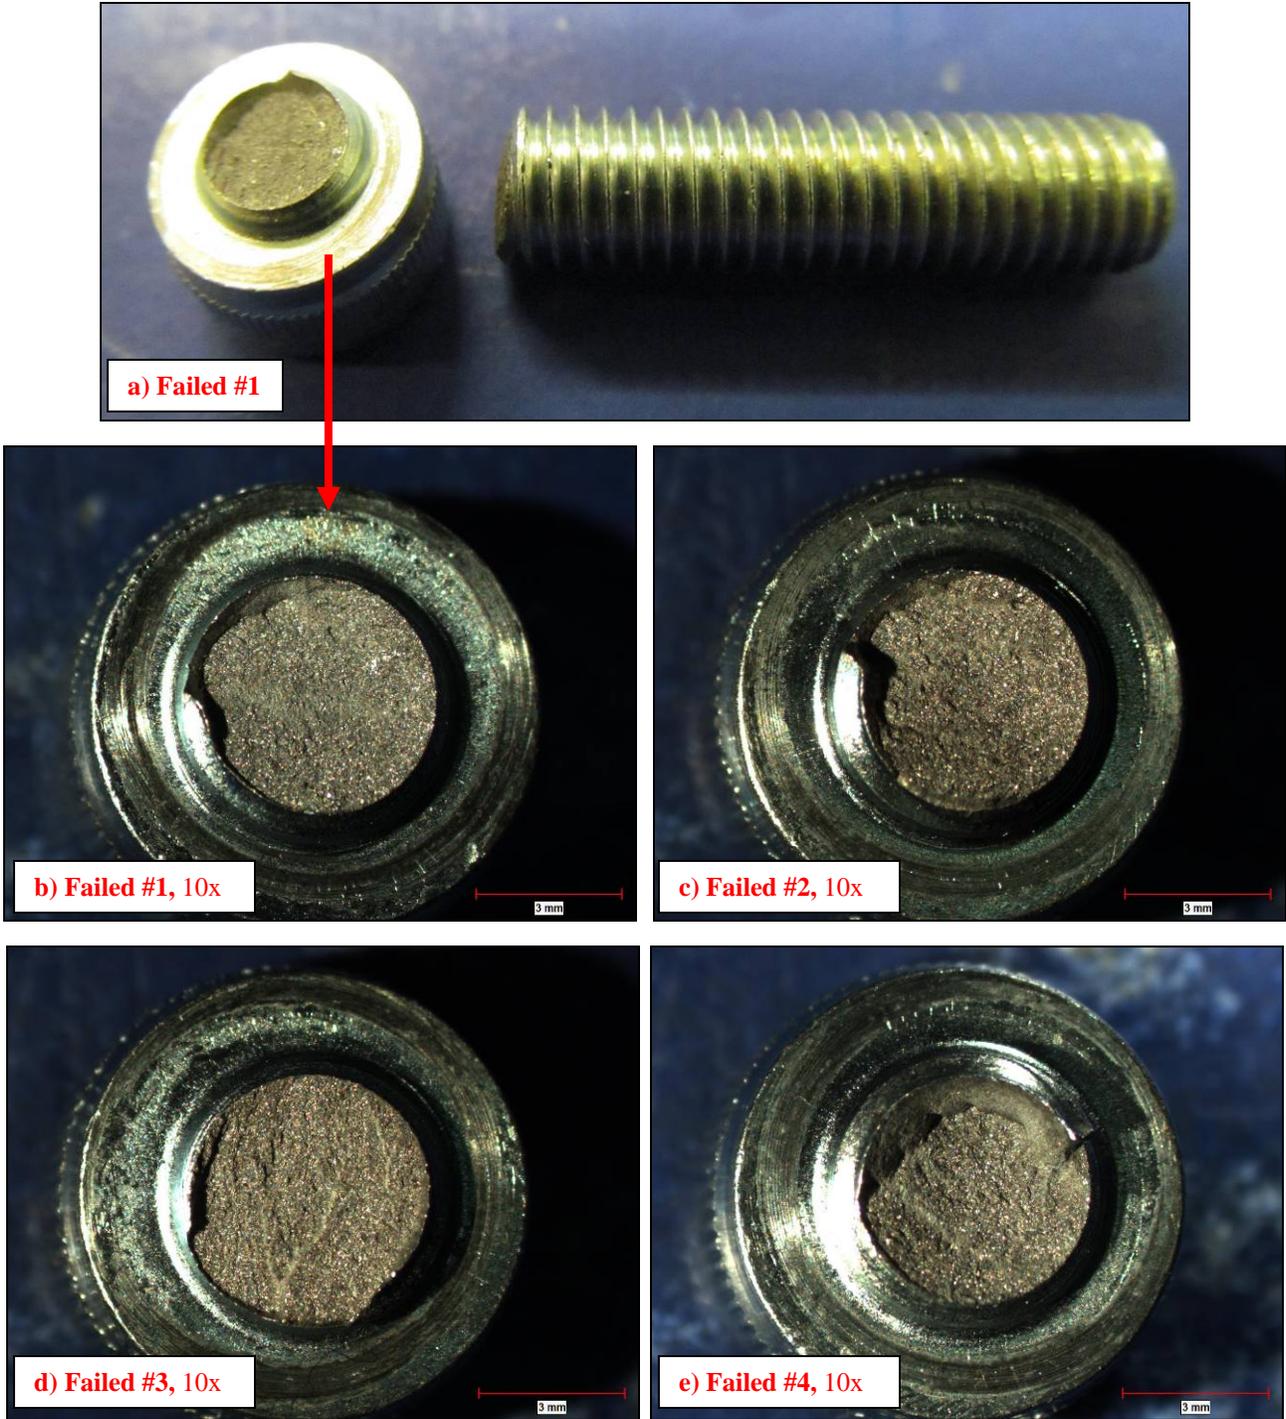
**Figure 2:** Photograph and macrographs displaying the four failed bolt heads. All four exhibited shiny, crystalline fracture features void of deformation.

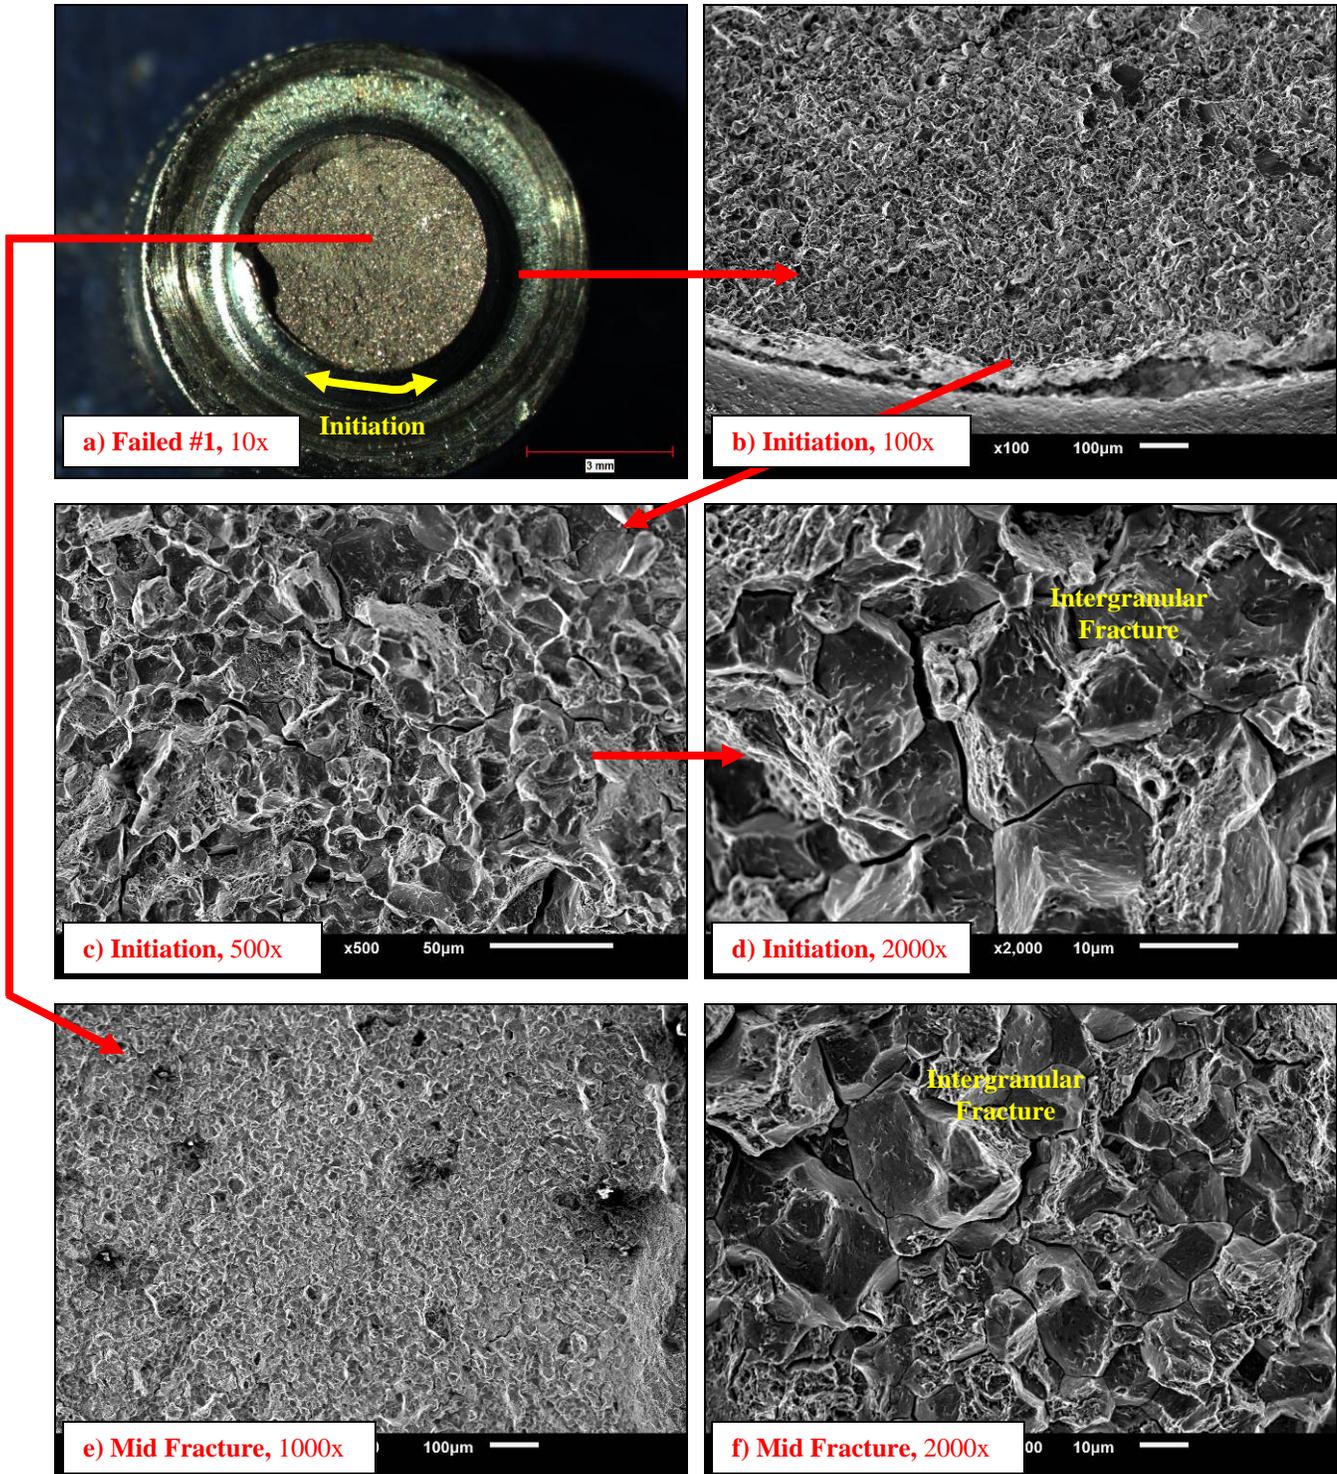
Failed Bolt #1 was cleaned using an ultrasonic cleaner and prepared for examination using a scanning electron microscope (SEM). The images are displayed in **Figure 3**. The fracture surface exhibited predominantly intergranular fracture features, associated with embrittlement of the material. Examination of the other failed bolt heads found them to exhibit the same majority intergranular fracture appearance.

**Figure 3:** Macrograph and SEM images of the fracture surface of Failed Bolt #1. The entirety of the fracture comprised of a mixed intergranular/microvoid failure mode indicating failure had occurred due to an embrittling phenomenon (later confirmed to be hydrogen embrittlement). SE1, 15kV.

Plated Grade 12.9 bolts require a proper bake-out to remove hydrogen introduced during acid cleaning and plating. Proper baking is the only method of ensuring reliability of plated, high strength bolts with hardness values of 39 HRC. ASTM F1941 recommends baking for 14-24 hours at 374°F to 428°F (190-220°C) for bolts with a hardness of ~44 HRC.

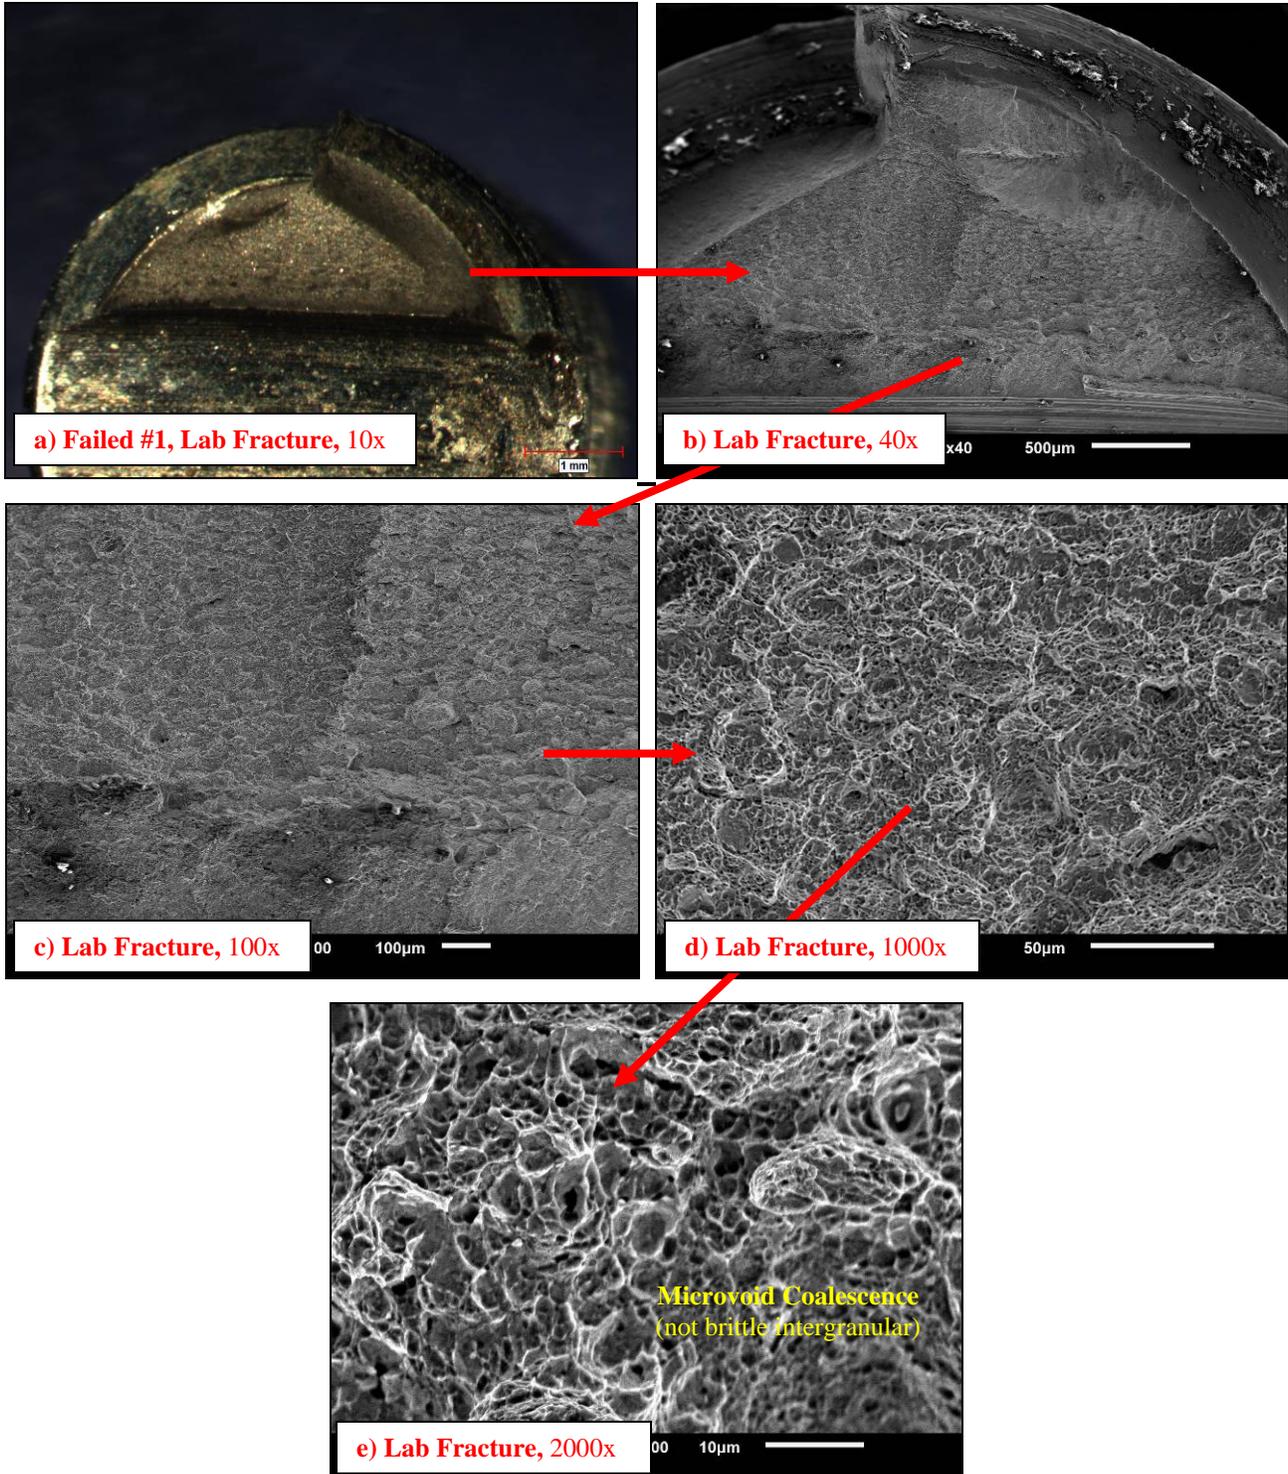
Lab fracture tests of the Failed and Good bolts were performed in an attempt to replicate the fracture appearance under simple overload conditions. Repeated tests found the bolts to consistently demonstrate a ductile appearance (**Figure 4**). This indicated that the material was ductile and ruled out intergranular fracture had been caused tempered martensite embrittlement or liquid metal embrittlement.

**Figure 4:** Macrograph and SEM images of the fracture surface of the lab fractured Failed Bolt #1. The entirety of the fracture exhibited microvoid coalescence fracture features consistent with ductile overload and quite different from the actual fractures under investigation. Therefore, the material was ductile under overload conditions. SE1, 15kV.

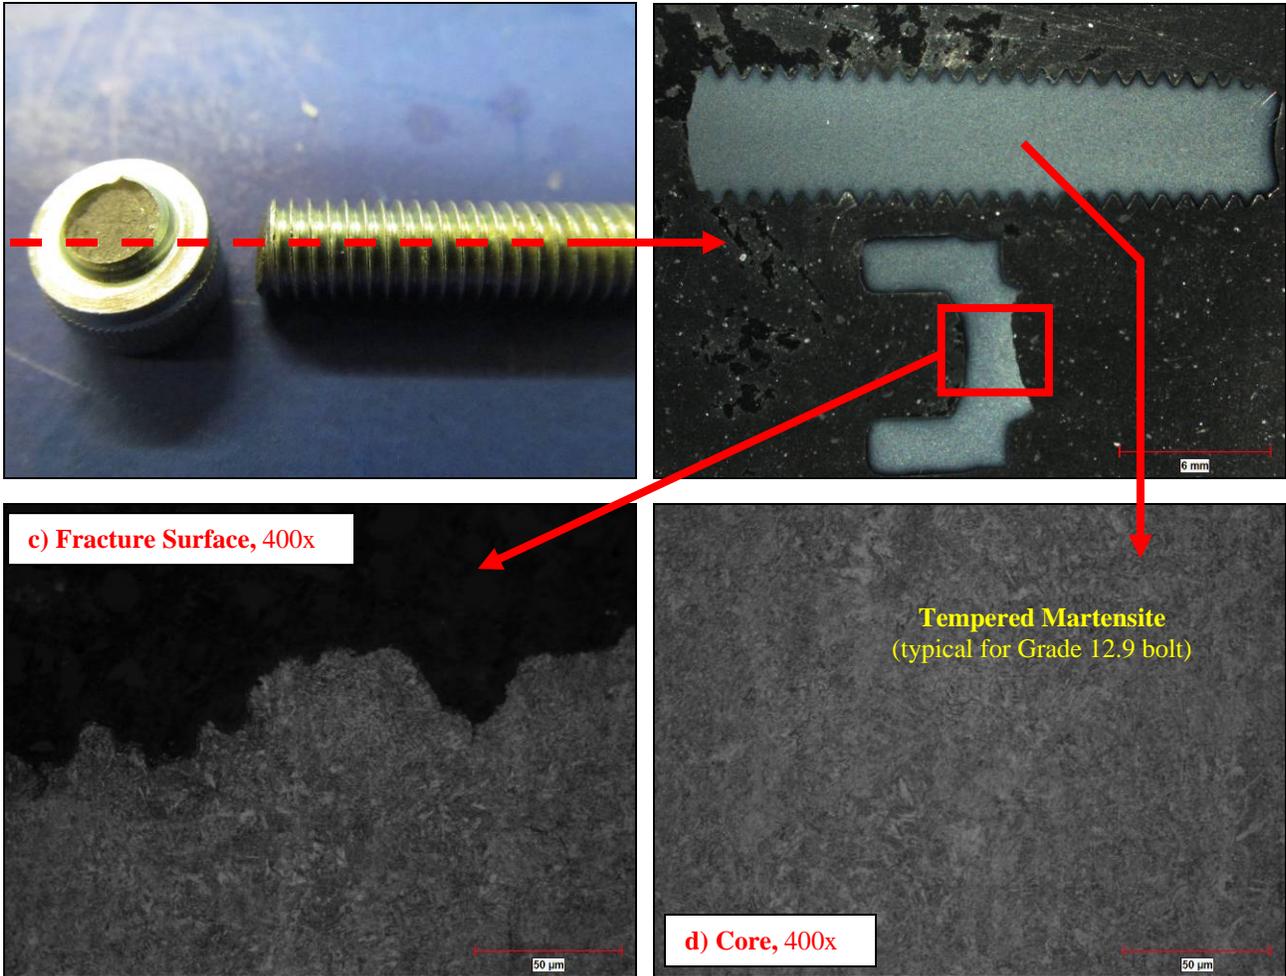
Cross-section were taken through Failed Bolt #1 and Good Bolt #1 and prepared for optical examination in accordance with ASTM E3. The images are displayed in **Figure 5 and 6**. Overall the crack path was linear with no branching. No quality issues or concerns were observed with the bolt material. Both the Failed and Reference bolts displayed a martensitic microstructure typical for a quench and tempered alloy steel.

**Figure 5:** Photograph, macrograph and micrographs displaying the cross-section taken through Failed Bolt #1. The fracture did not feature any branching or secondary cracking. The core structure comprised of tempered martensite typical for Grade 12.9 bolts. No quality issues or concerns were observed in the fracture region by optical microscopy. Etched using 3% nital.
