DAMAGE SURVEY OF A FAILED STEAM BOILER

EXAMPLE REPORT

DAMAGE SURVEY OF FAILED STEAM BOILER

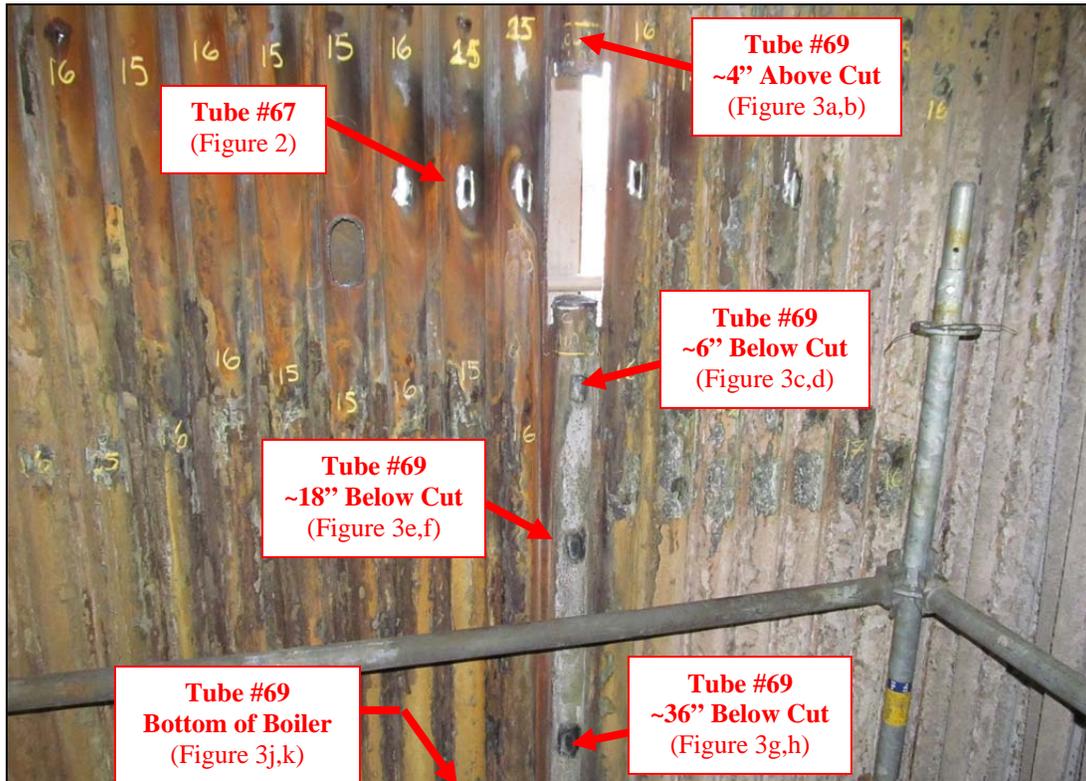
Figure 1: Photograph displaying the locations evaluated on the Failed Tube #69.

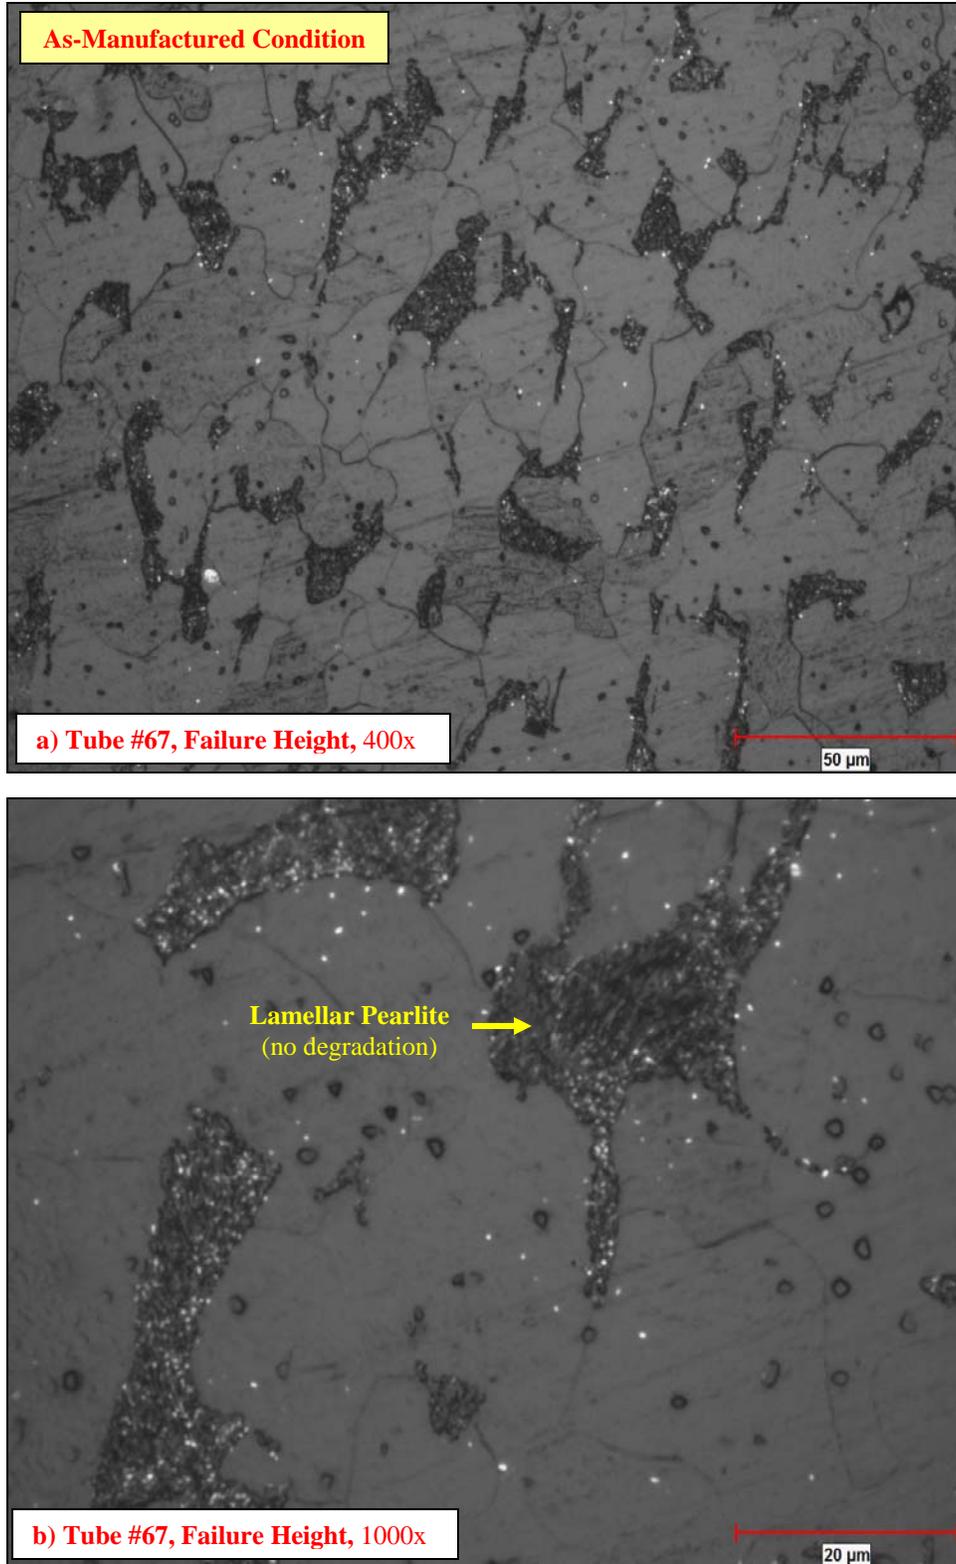
Figure 2: Micrographs taken from replicas of Tube #67 at the same height as failure of Tube #69. The microstructure comprised of ferrite and lamellar pearlite, typical for the as-manufactured ASTM A192 tube (ie. as-new structure, Level A-B spheroidization). This provided a benchmark to which the degradation of Tube #69 was compared against. Images taken from replication, tube etched with 3% nital.

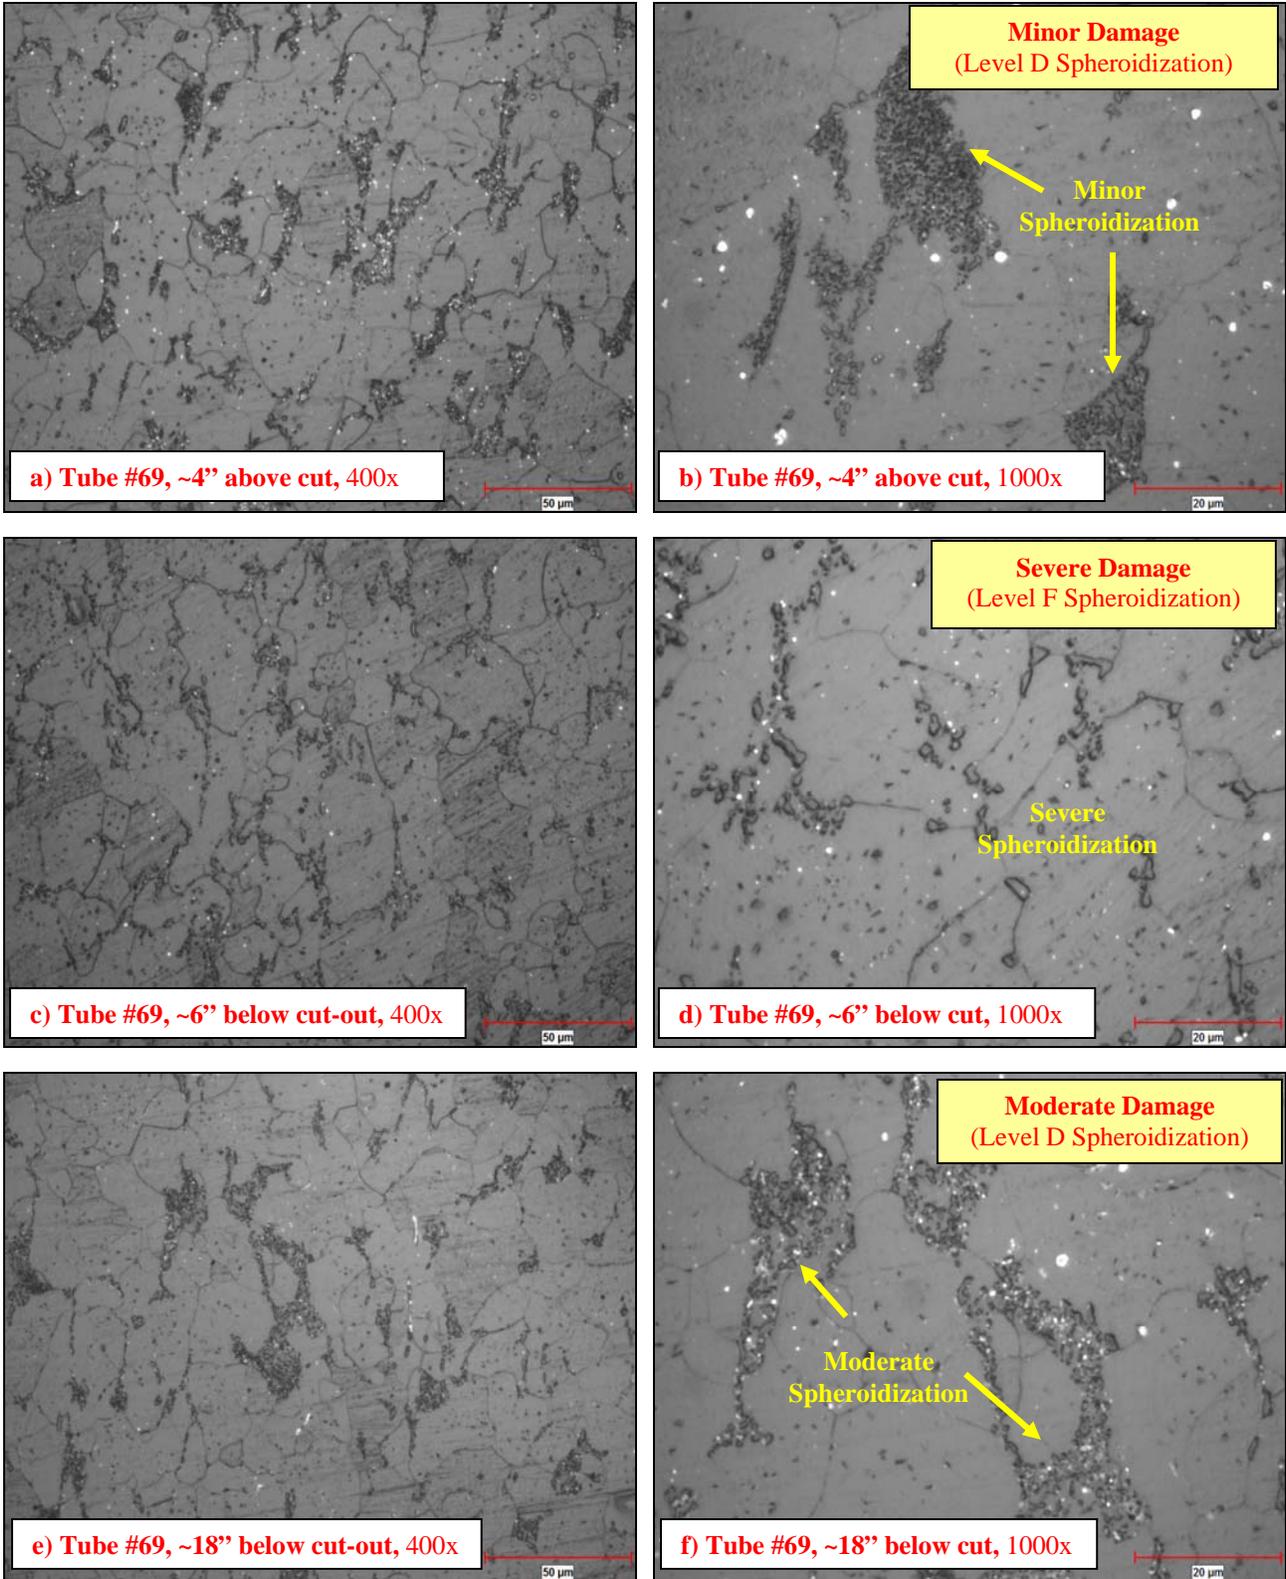
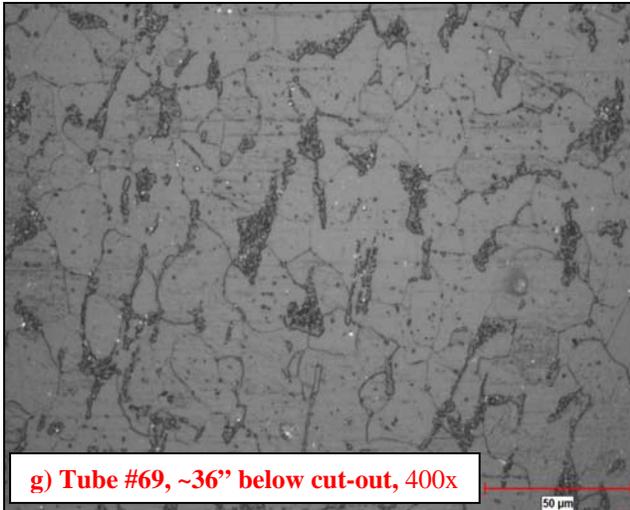
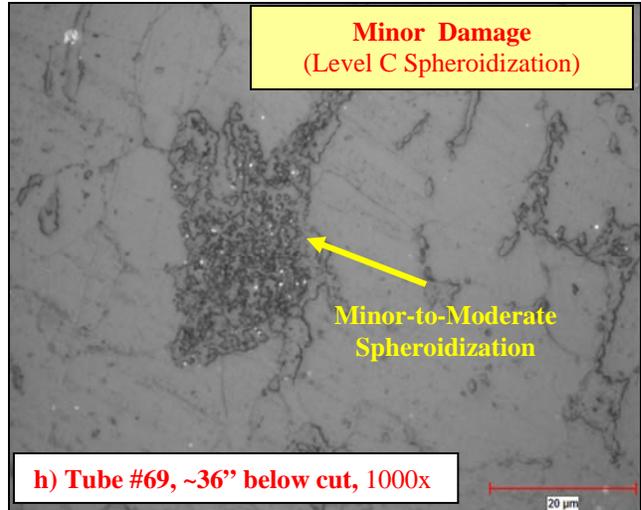
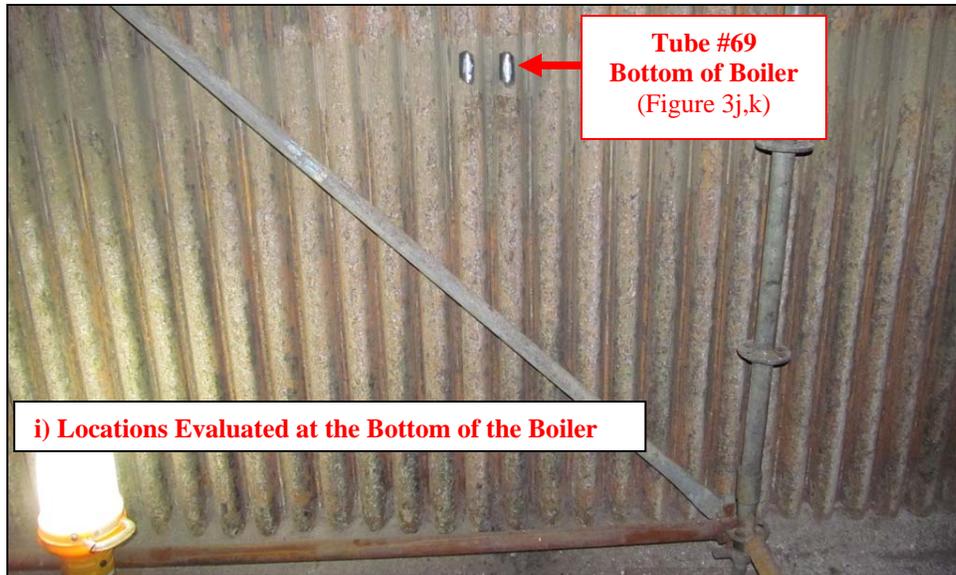
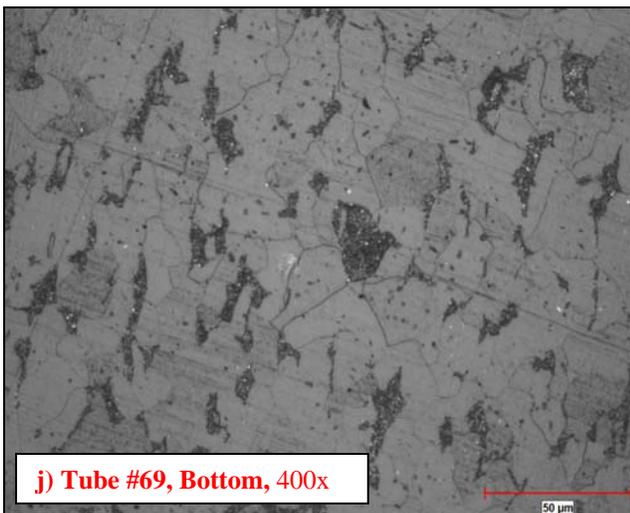
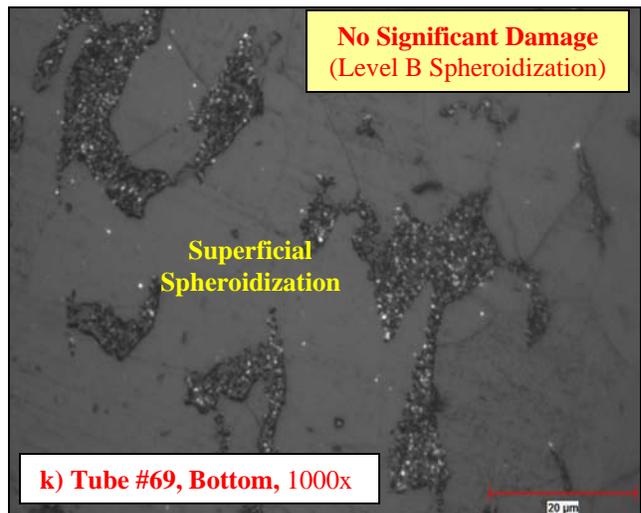
Figure 3 Continued.

Table 1 summarizes the results from the survey. Optical examination of the replications found Ruptured Tube #69 to exhibit severe spheroidization immediately beneath the cut-out (**Figure 3c,d**). The degree of spheroidization beneath the cut-out rupture site was rated as Level F (rating chart in **Appendix A**). This damage had been caused by days, weeks or even years of overheating. No creep voids was observed at this site yet, based upon the degree of sensitization, rupture was suspected to have occurred by creep damage from prolonged overheating.

Advanced, Level F spheroidization beneath the cut-out rupture site was consistent with overheating. Although analysis of the rupture itself would be required for a conclusive diagnosis, the advanced spheroidization made it likely that tube rupture had been caused by prolonged overheating and creep failure.

Figure 3: Micrographs of Failed Tube #69 (a,b) above the cut-out, (c-h) at various locations below the cut-out and (j,k) at the bottom of the boiler. The degradation was most severe immediately below the cut-out. Tube #69 was in good condition at the base of the boiler. No creep voids were observed at any of the sites evaluated.

Note that once damaged material on Tube #69 was found, it was clear that the intended repair plan had not removed all the damaged material. In-situ was used to survey how far above and below the microstructural damage continued (**Figure 3**). Based upon these findings, an additional foot was removed above the cut-out and another three feet cut out below. This ensured no thermally damaged pipe remained in the boiler.

In-situ metallography was used to ensure that all the thermally damaged Tube #69 material was removed during the repair.

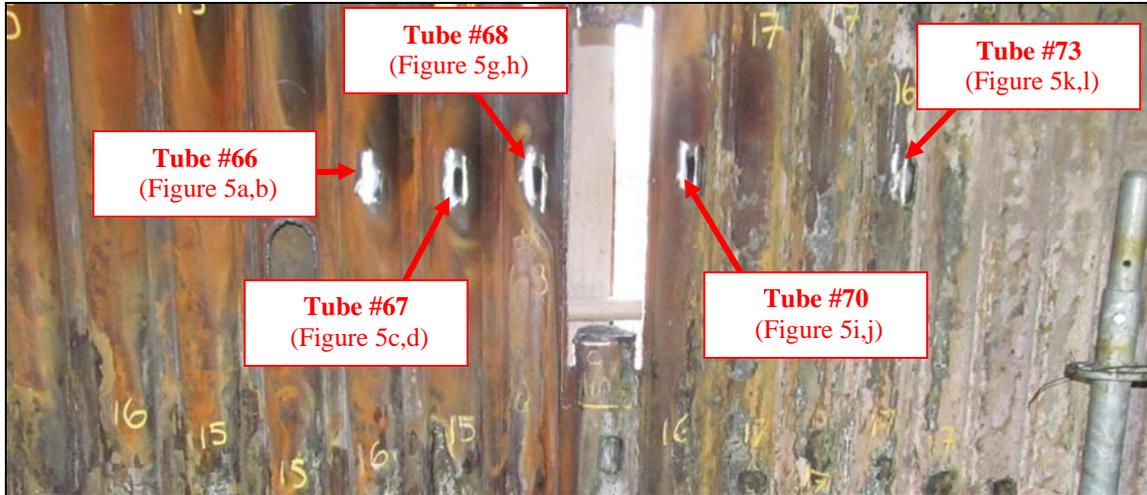
Figure 4: Photograph displaying the locations evaluated on the neighbouring tubes adjacent to the failure. These tubes were evaluated at the same height as failure, plus Tube #68 was evaluated at the boiler bottom.

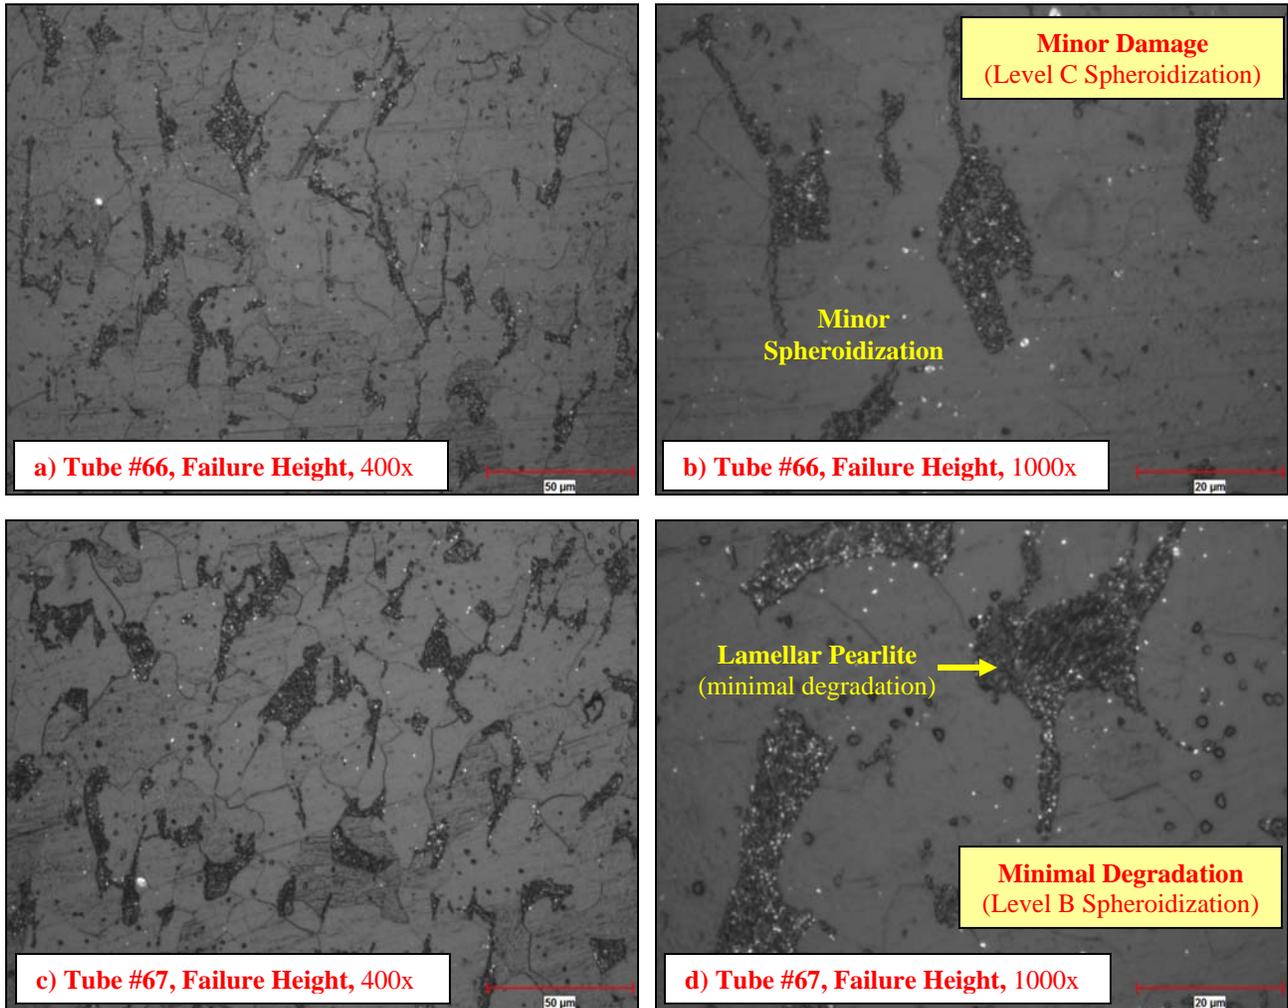
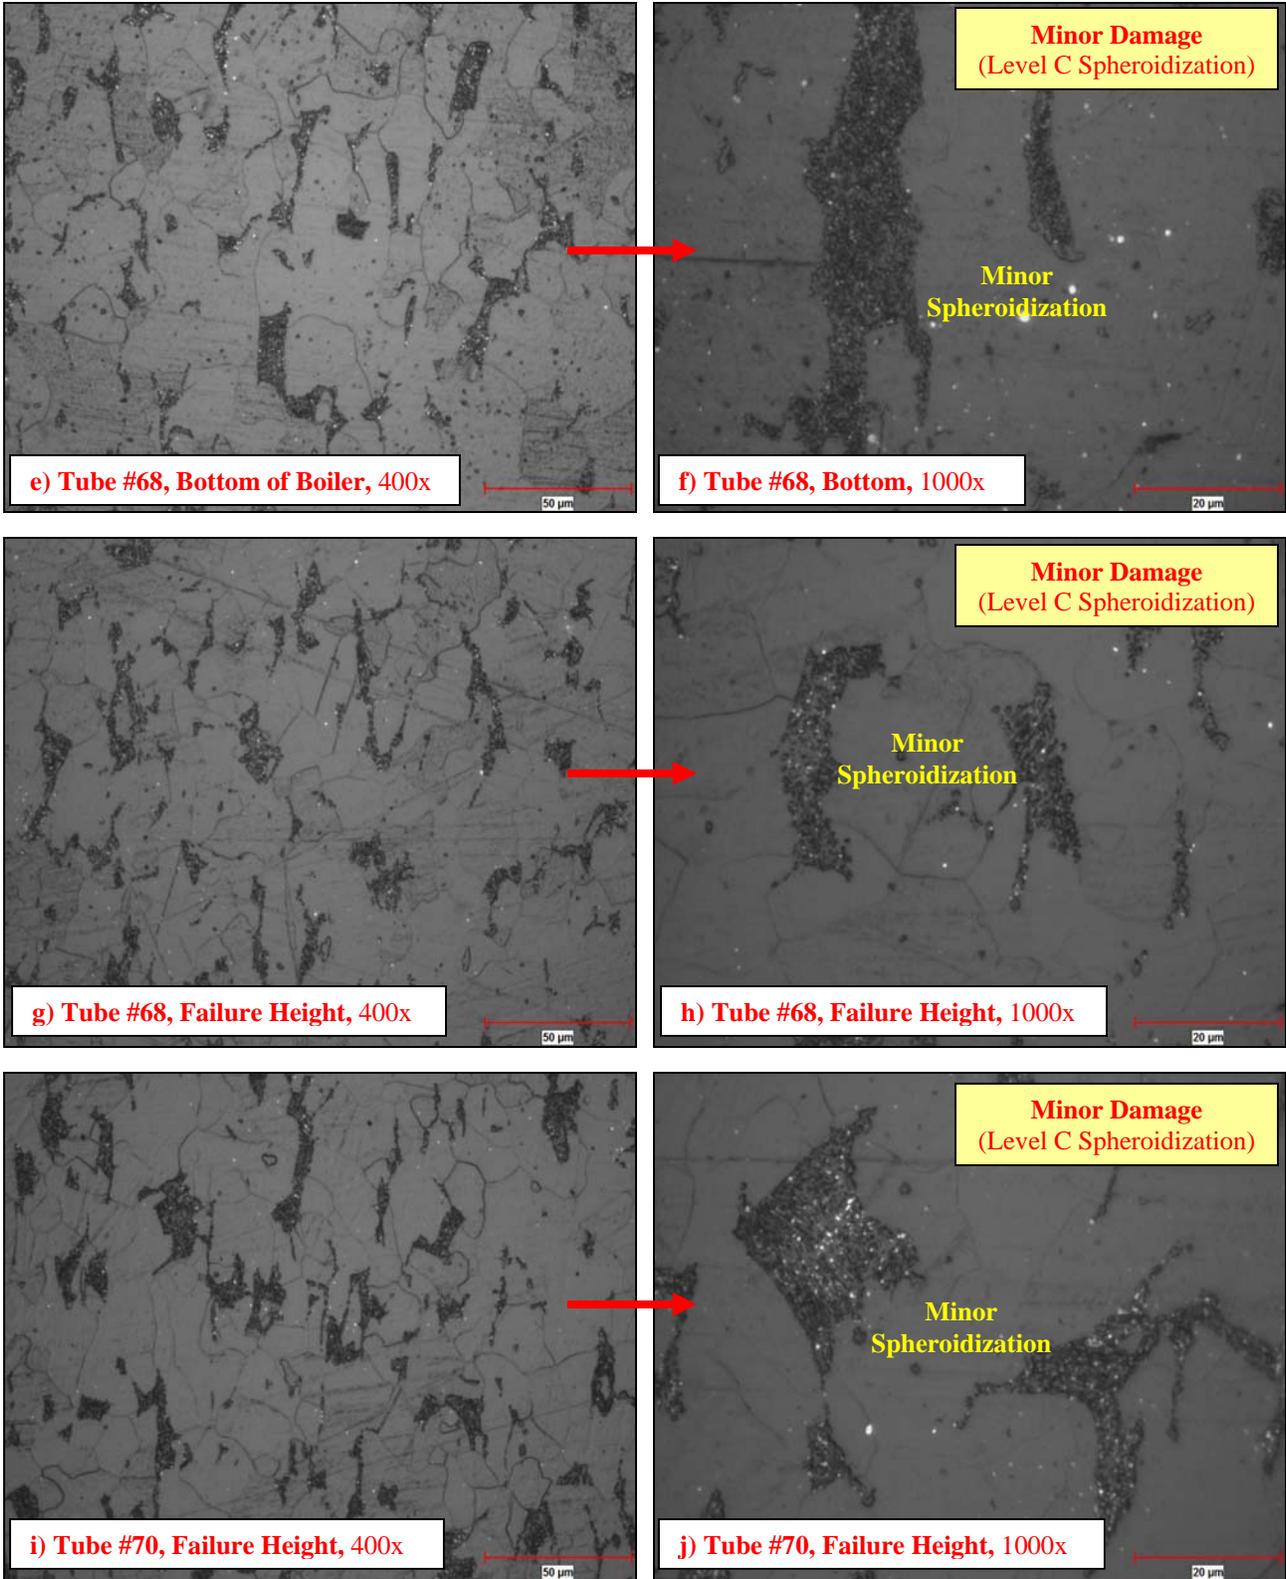
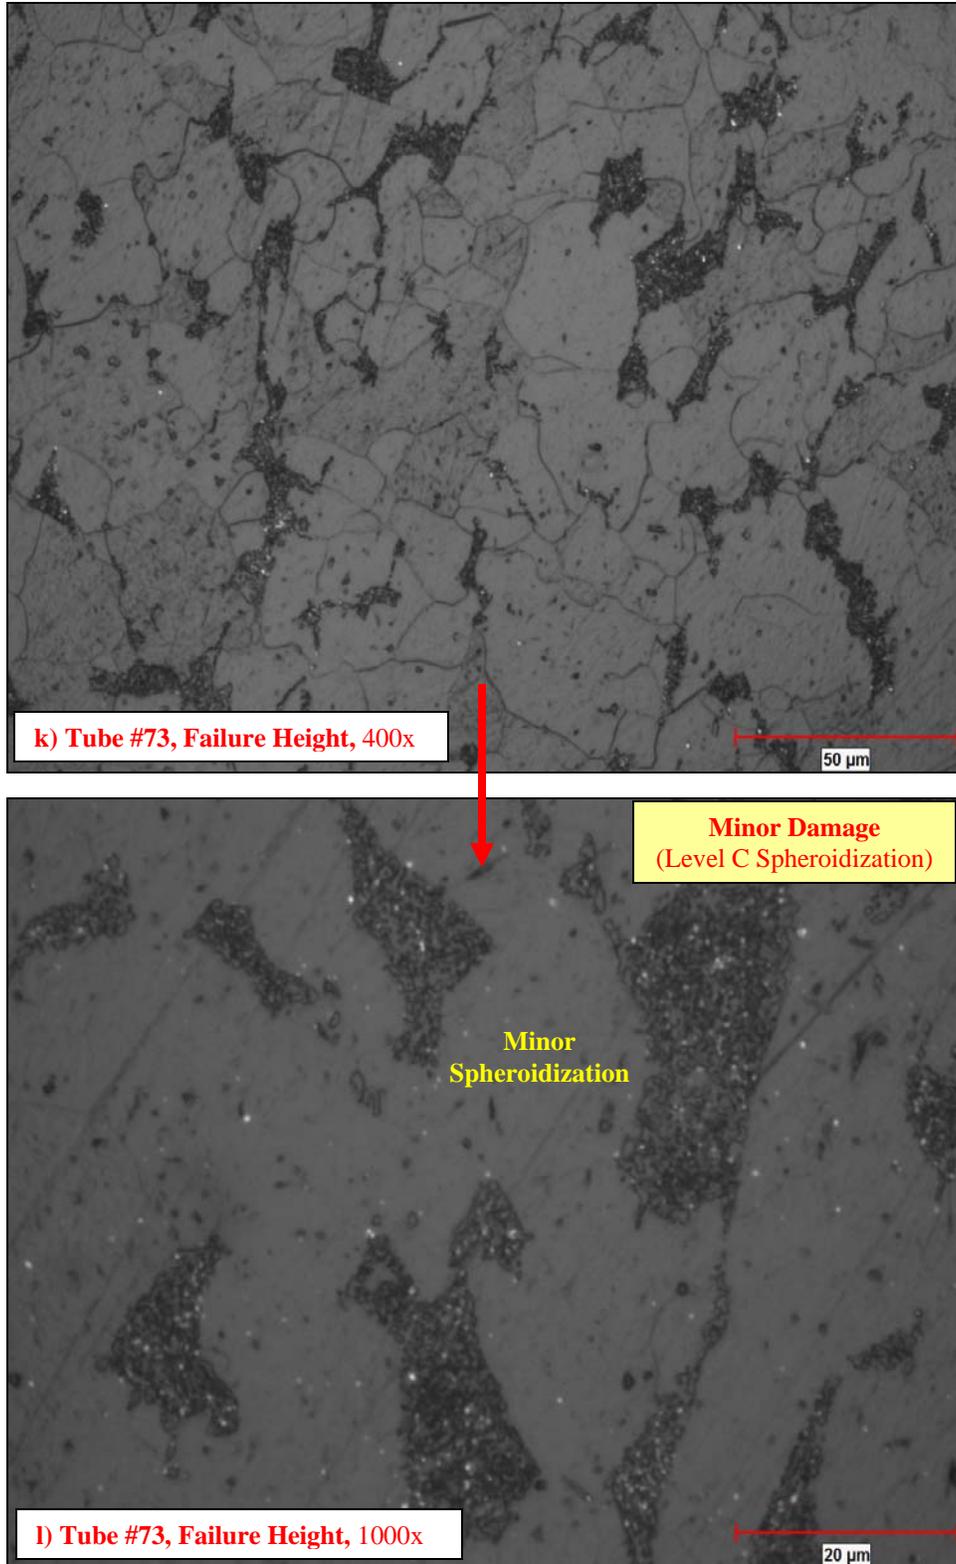
Figure 5 Continued.

In-situ metallography of the neighbouring Tubes #66, #67, #68, #70 and #73 found them to be in relatively good condition considering their thirty years of service (**Figure 5**). No creep voids were observed and each tube exhibited only minor spheroidization (Level C). These tubes had not experienced the same elevated temperatures as Ruptured Tube #69. This suggested that Tube #69 had experienced reduced flow/cooling resulting in increased wall temperatures.

None of the neighbouring tubes exhibited indications of overheating. The increased operating temperature of Ruptured Tube #69 alone suggested a blockage restricting water flow. The neighbouring tubes had experienced adequate flow and were not at risk of having a similar creep failure.

Figure 5: Micrographs of the neighbouring tubes to the failure. These tubes had not experienced the same, elevated temperatures during service as Tube #69 and were in good condition given their years of service.
