# IN-SITU METALLOGRAPHY OF HEATER TUBES

## EXAMPLE REPORT

## IN-SITU METALLOGRAPHY OF HEATER TUBES

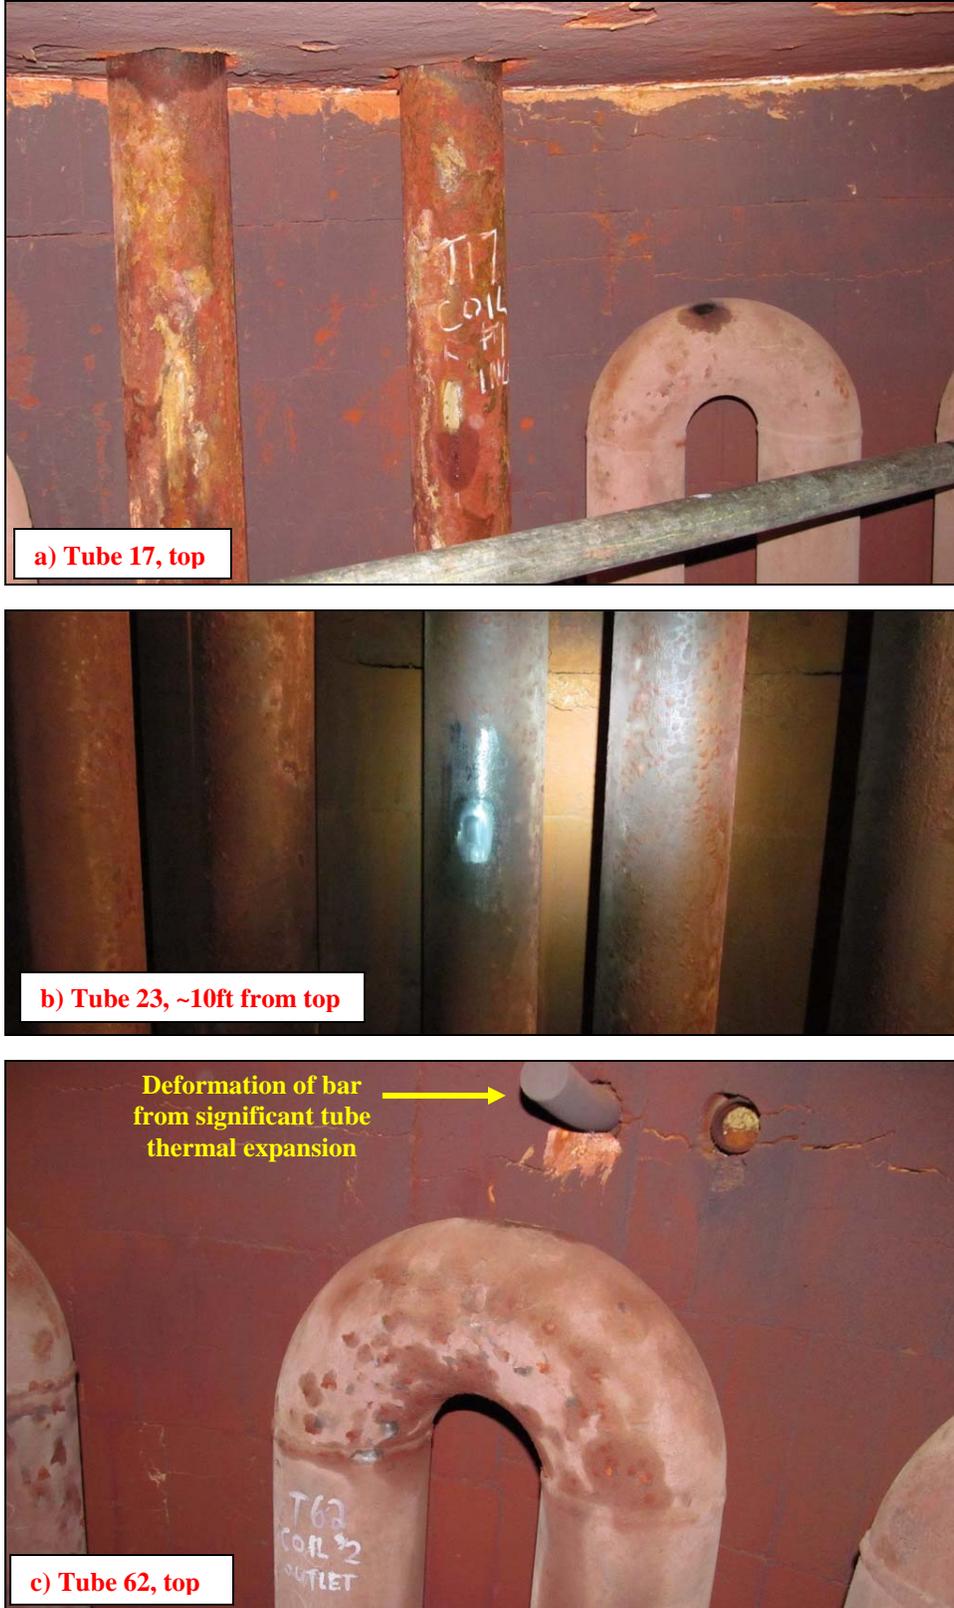
**Figure 1** displays examples of the sites evaluated by in-situ metallography and hardness testing. Also illustrated was deformation of a bar indicating thermal expansion from overheating (**Figure 1c**).

**Figure 1:** (a,b) Photographs displaying examples of the sites evaluated by in-situ metallography and hardness testing. (c) Due to overheating, the tubes had experienced significant thermal expansion.

The tubes appeared to have operated without issue since the excursion. No creep damage or other life-limiting mechanisms were observed. No features were observed that would warrant immediate concern and it was likely these tubes would be fit for continued service as-is. It is recommended that the client perform a fitness-for-service evaluation to valid their suitability for continued service.

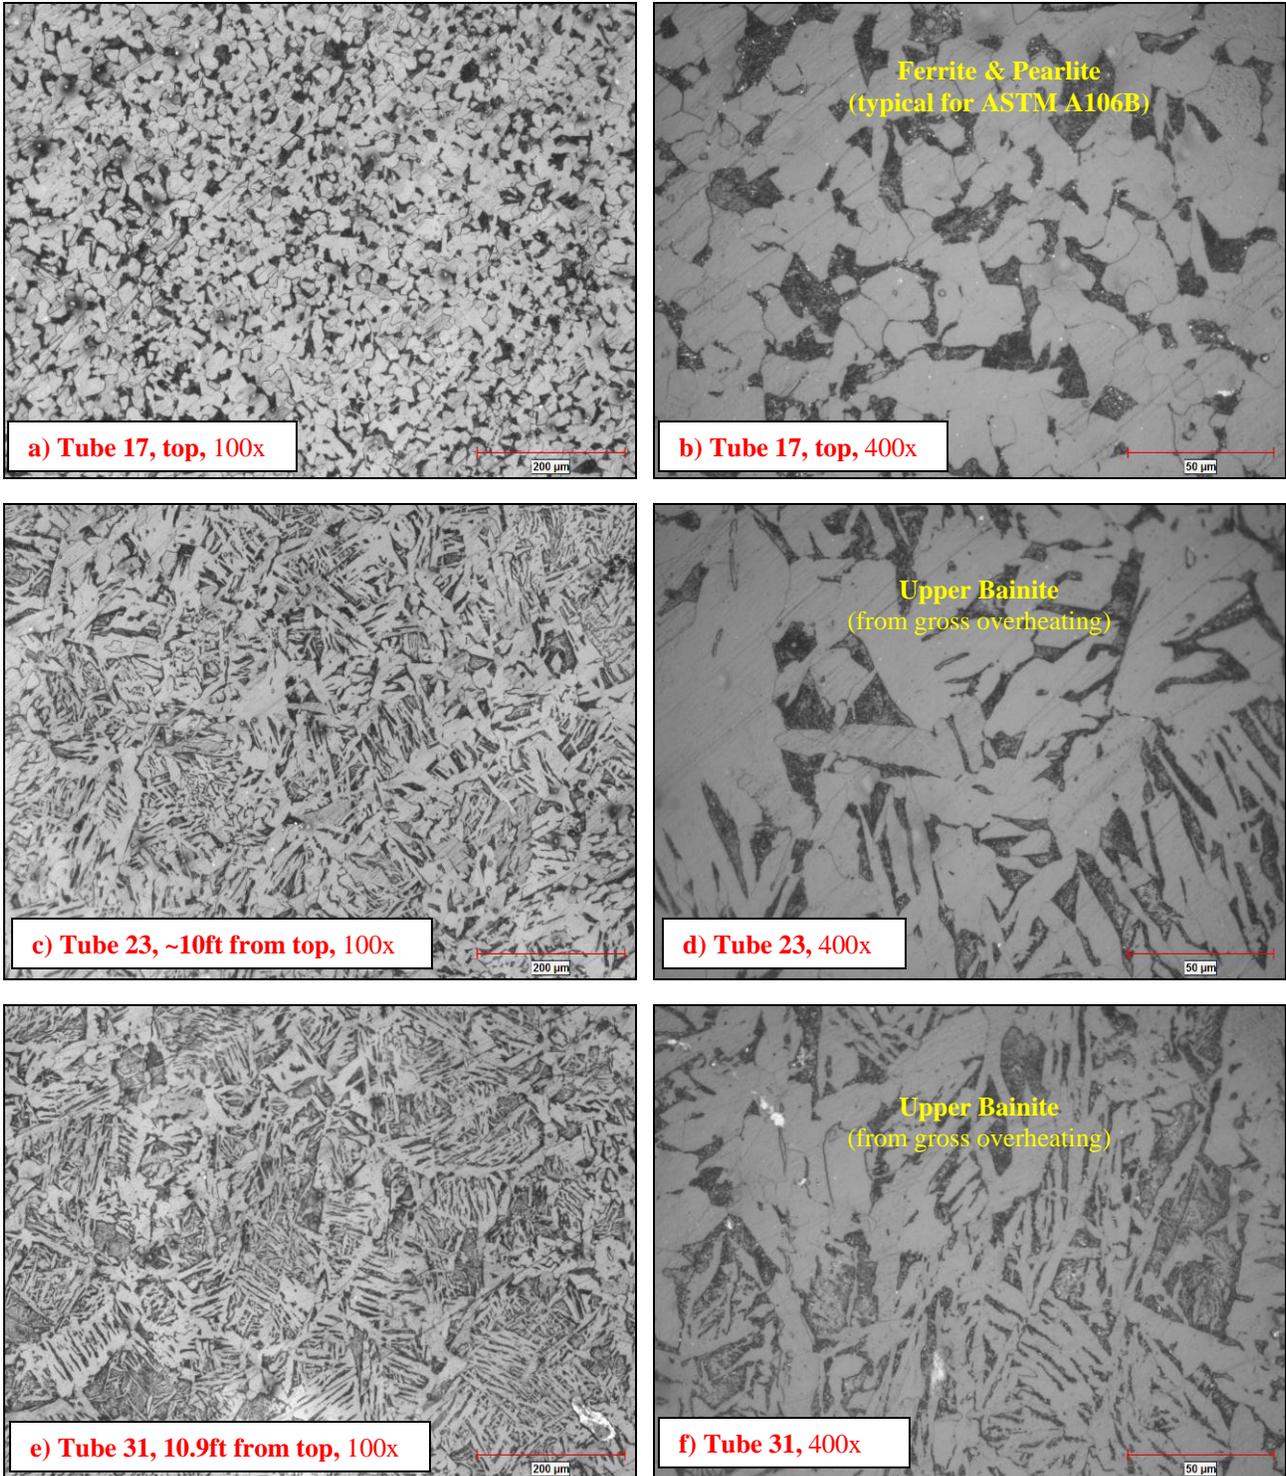
Inlet Tube #17 (coolest tube), selected as a reference location, comprised of a ferritic and pearlitic structure typical for as-manufactured ASTM A106 Grade B tube (**Figure 2a,b**). No notable thermal degradation had occurred at this site (Level A spheroidization, Stage 1 creep, rating chart in **Appendixes A and B**).

The other sites evaluated on the tubes, corresponding to diametrical growth, all exhibited upper bainitic structures (**Figure 2c-j**). These structures indicated that these tubes had experienced an excursion above 1600°F (>871°C), then cooled relatively quickly. No creep voids or cracking was observed (Stage 1 creep).

The bainitic microstructures found on Tubes #23, #31 and #62 indicated that they had at some point experienced an excursion above 1600°F (>871°C) then cooled relatively quickly. This type of thermal pattern matched well with product flow interruption during operation, causing the tubes to overheat. During re-introduction of product flow, the tubes had quenched at a moderate rate, forming the bainitic structure.

**Figure 2:** (a,b) The inlet Tube #17 comprised of a structure typical for an as-manufactured ASTM A106B carbon steel. No thermal degradation was observed. (c-j) The structures at the other locations, including those exhibiting diametrical growth, comprised of upper bainite. These locations had reached temperatures above >1600°F (>871°C). No creep voids were observed. Images taken from replications, etched on-site using 3% nital.
