IN-SITU METALLOGRAPHY OF CRACKED CARBONATE REBOILER SHELL

EXAMPLE REPORT

IN-SITU METALLOGRAPHY OF CRACKED CARBONATE REBOILER CHANNEL

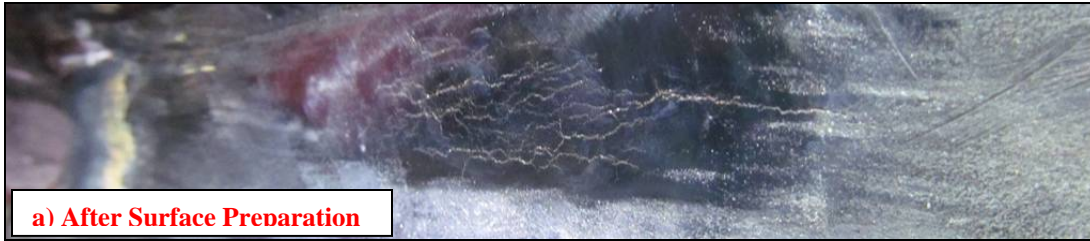
Optical examination of the replications found the networks of branched cracks to be consistent with stress corrosion cracking (SCC, **Figures 2 and 3**). The cracks tended to be transgranular in nature. Transgranular SCC cracking of 304 stainless steel is most often caused by aqueous chlorine/chlorides.

Figure 2: Micrographs displaying examples of the external cracks adjacent the nozzle. The branched nature of the cracks was consistent with stress corrosion cracking (SCC). The cracks were transgranular.

The external surface should have been dry and stress corrosion cracks indicated that copious amounts of water had been introduced over months if not years. Therefore, corrosion was consistent with corrosion under insulation (CUI). Images taken from replications.
